Stage 2 Interim Action Report for the Former Satralloy Site (Jefferson County, Ohio)

Cyprus Amax Minerals Company

WSP USA Inc.

October 2023

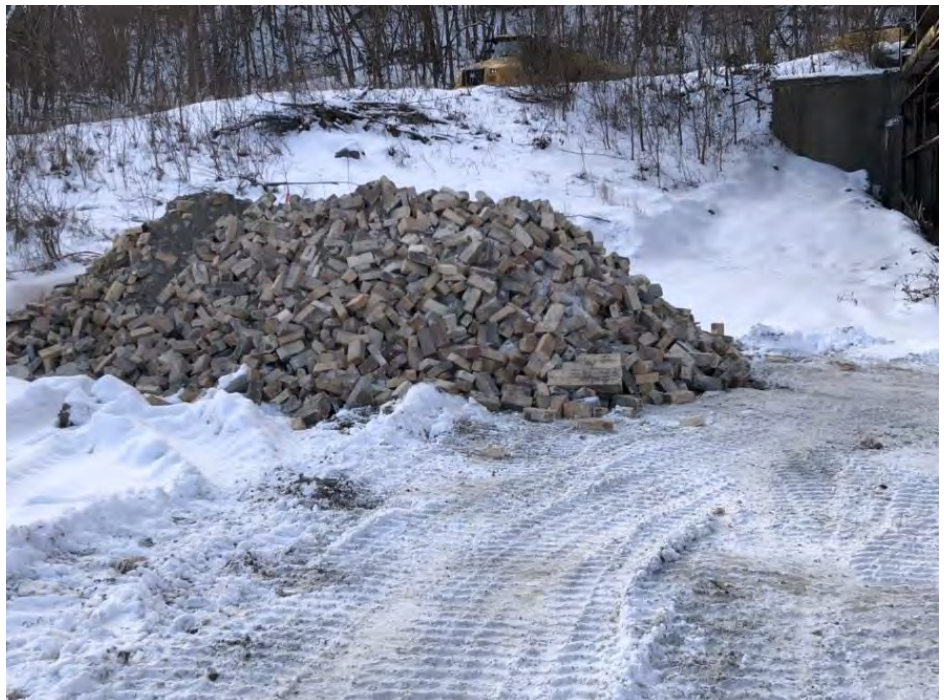
PHOTOGRAPH 21

Staged refractory brick from the South Mill Building.

The refractory brick was transported off-site in two rail gondolas for disposal as hazardous waste at the US Ecology facility in Grandview, Idaho. As was done for the NMB dust, the refractory brick was placed inside RailPac® liners in each gondola, which were sealed prior to off-site transport. The two gondolas containing refractory brick were sent off-site in August 2022.

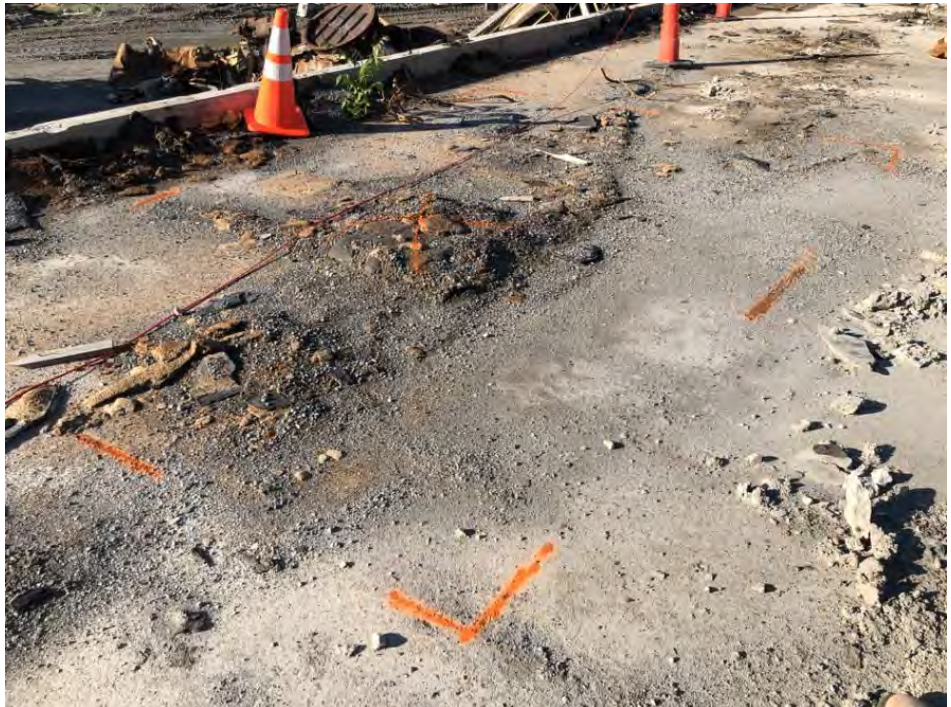
PHOTOGRAPH 24

The former maintenance shop of the NMB contained two concrete pedestals that were believed to have been used to hold electrical equipment. Oil staining was visible on both pedestals and a portion of the concrete floor around them. This area had been sampled for PCBs in January 2019, and the results indicated the presence of PCBs, with one sample above 50 milligrams per kilogram, which is the Toxic Substances Control Act (TSCA) threshold for disposal as PCB waste.

Concrete pedestal in North Mill Building with PCB contamination.

The PCB-impacted concrete was removed for off-site disposal as PCB waste. Even though only one of the pedestals was shown to exceed the TSCA limit, both of the oil-stained pedestals and a wider area of impacted concrete slab around them were removed. In June 2022, RECON used an excavator with a concrete hammer attachment to remove the concrete pedestals and surrounding slab and break them into manageable pieces of concrete debris. The debris was then loaded into two trucks for transportation to the US Ecology facility in Belleville, Michigan.

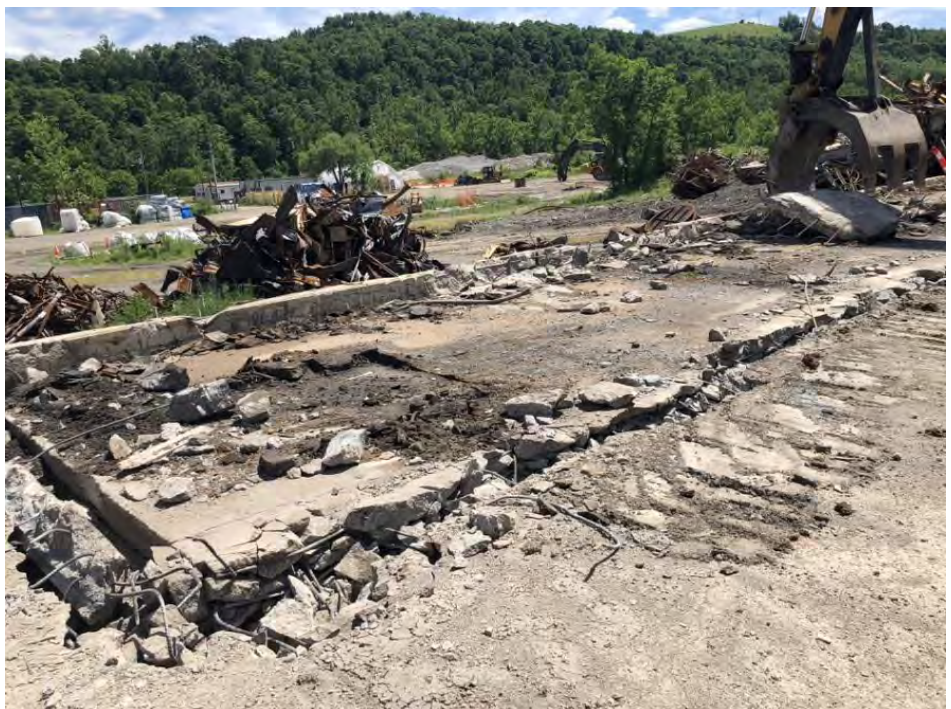
PHOTOGRAPH 25

Removal of concrete contaminated with PCBs at the North Mill Building.

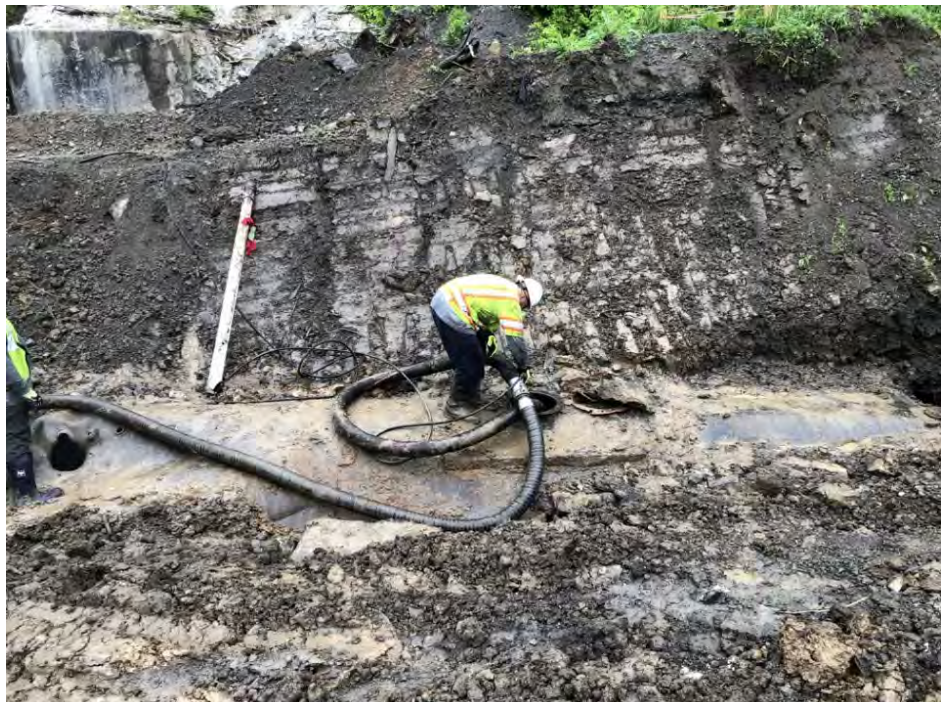
PHOTOGRAPH 51

The UST decommissioning work was performed by Clean Harbors. In May 2022, the UST was opened to assess its condition and was found to contain approximately 12 inches of water, which had possibly been trapped from previous groundwater infiltration. A sample of the liquid was collected and analyzed for waste disposal parameters, and the results indicated that the liquid was non-hazardous.

Cleaning the 10,000-gallon
heating oil UST.

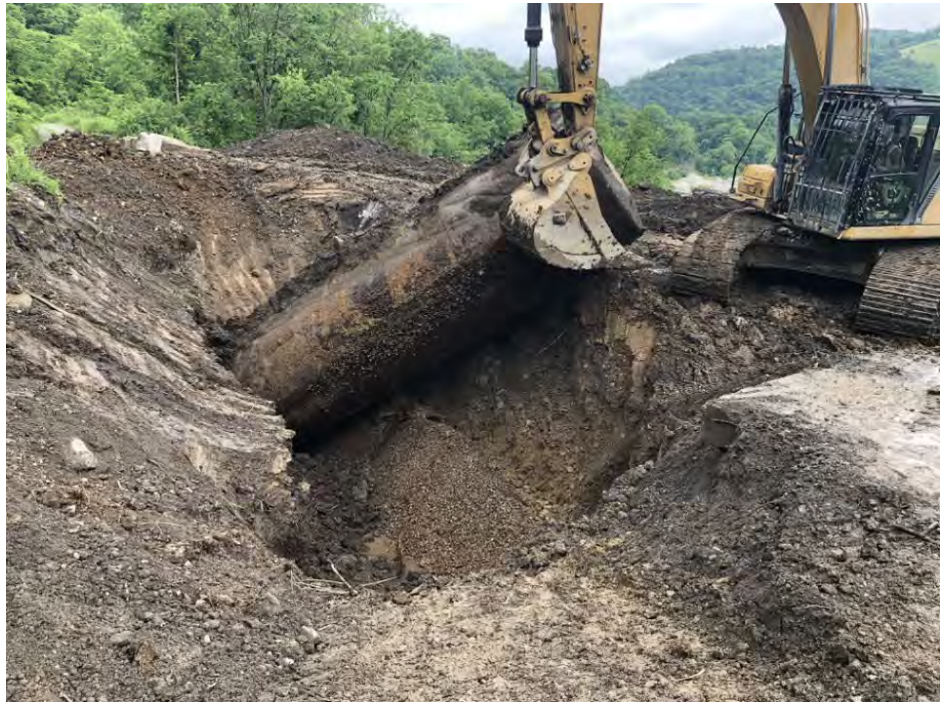
PHOTOGRAPH 52

Removing the 10,000-gallon heating oil UST from the ground.

After the UST was removed, soil from the excavation area (floor and sidewalls) and the spoils piles was sampled for field testing and off-site laboratory analyses per BUSTR. Closure samples were collected from the tank cavity floor and sidewalls following the recommended procedures in the BUSTR Technical Guidance Manual for closure assessments. Soil samples were collected from the excavated backfill in accordance with BUSTR Petroleum Contaminated Soil regulations. Samples were collected and field-screened using a photoionization detector to select samples for laboratory analysis. A summary of the samples collected, and the field screening results, is provided in Table 1.

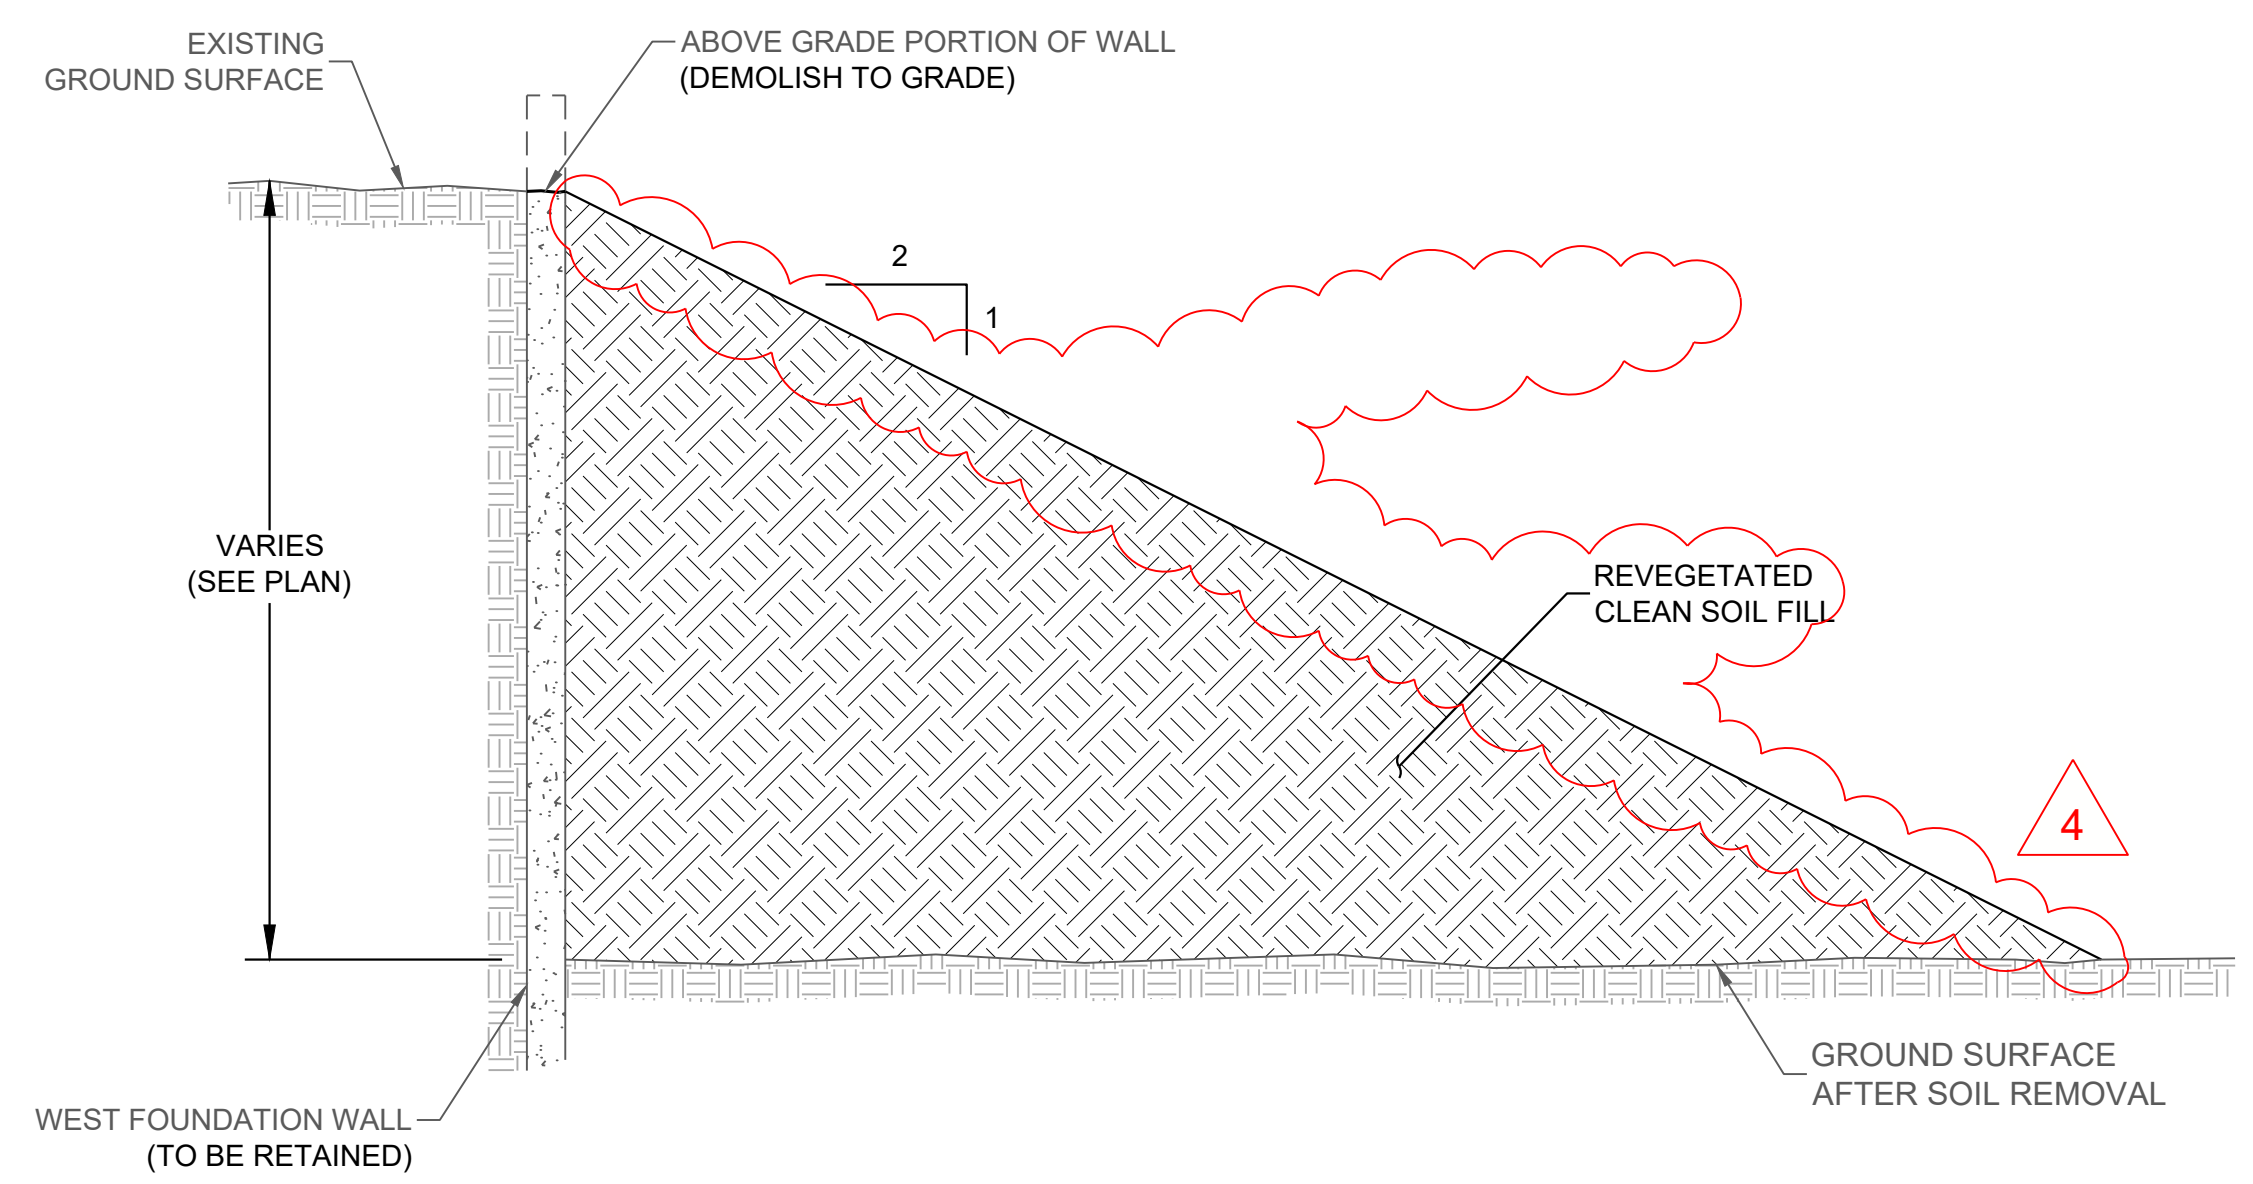
SCALE NTS **D** MILL BUILDINGS BACKFILL - TYPICAL SECTION
 IAR-230 IAR-240

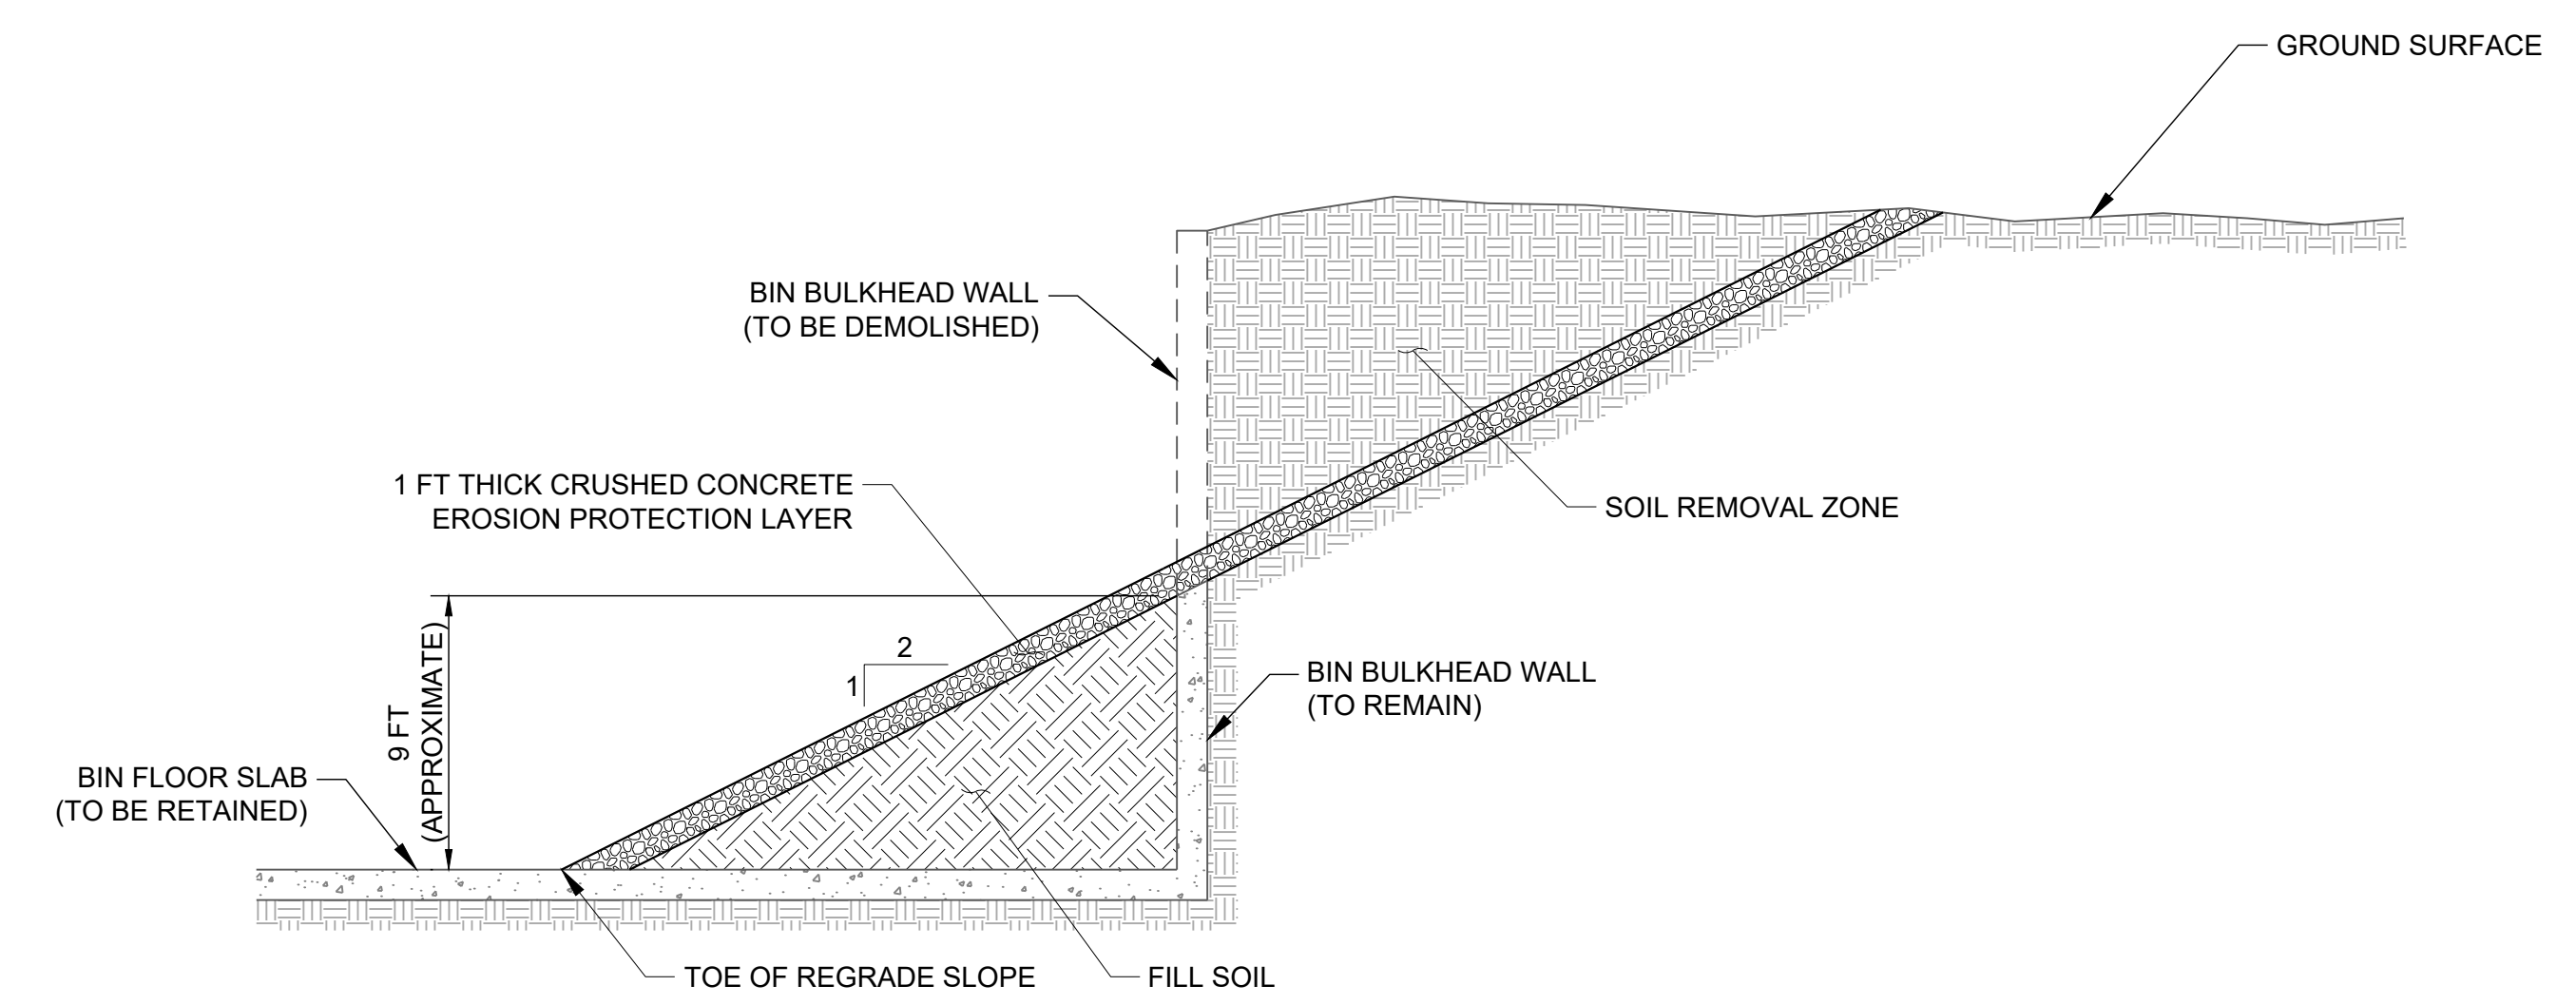
SCALE NTS **E** BIN BULKHEAD DEMOLITION - TYPICAL SECTION
 IAR-230 IAR-240

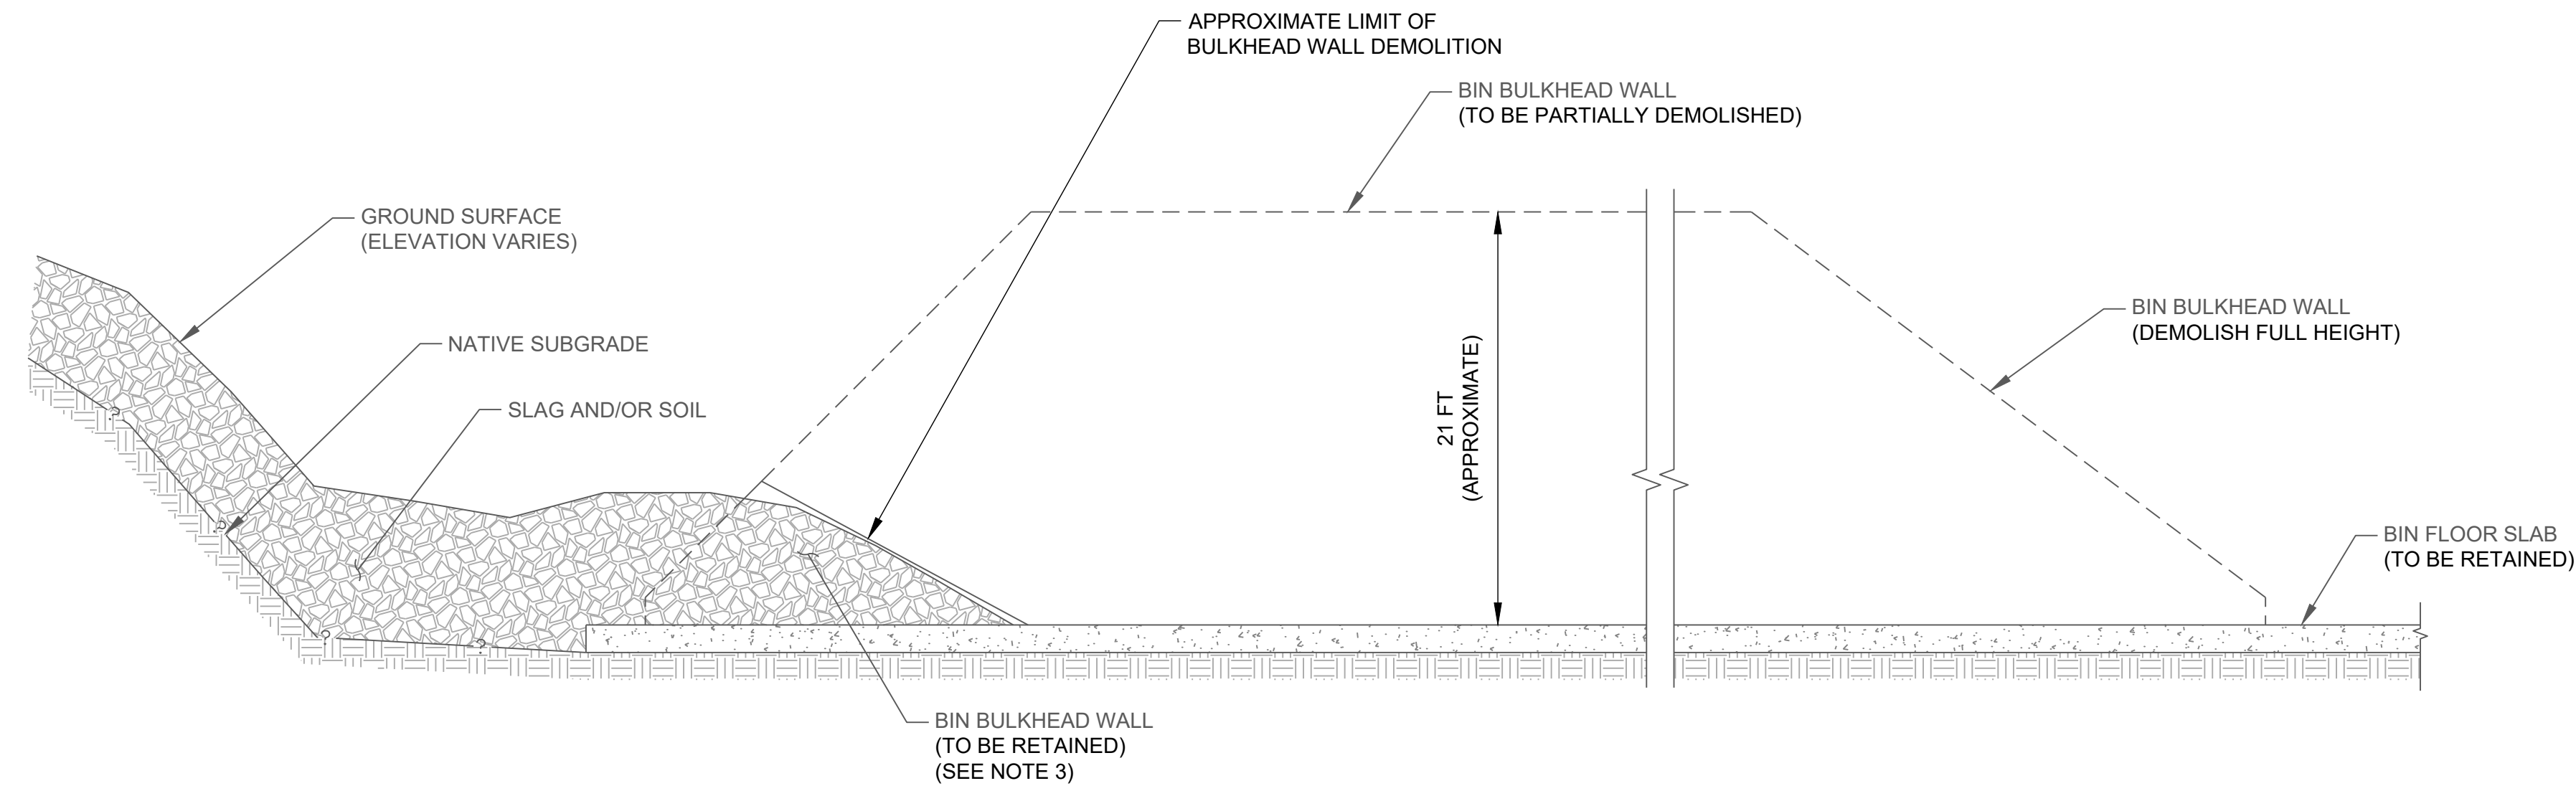
SCALE NTS **F** NORTH BINS WALL DEMOLITION - TYPICAL SECTION
IAR-230

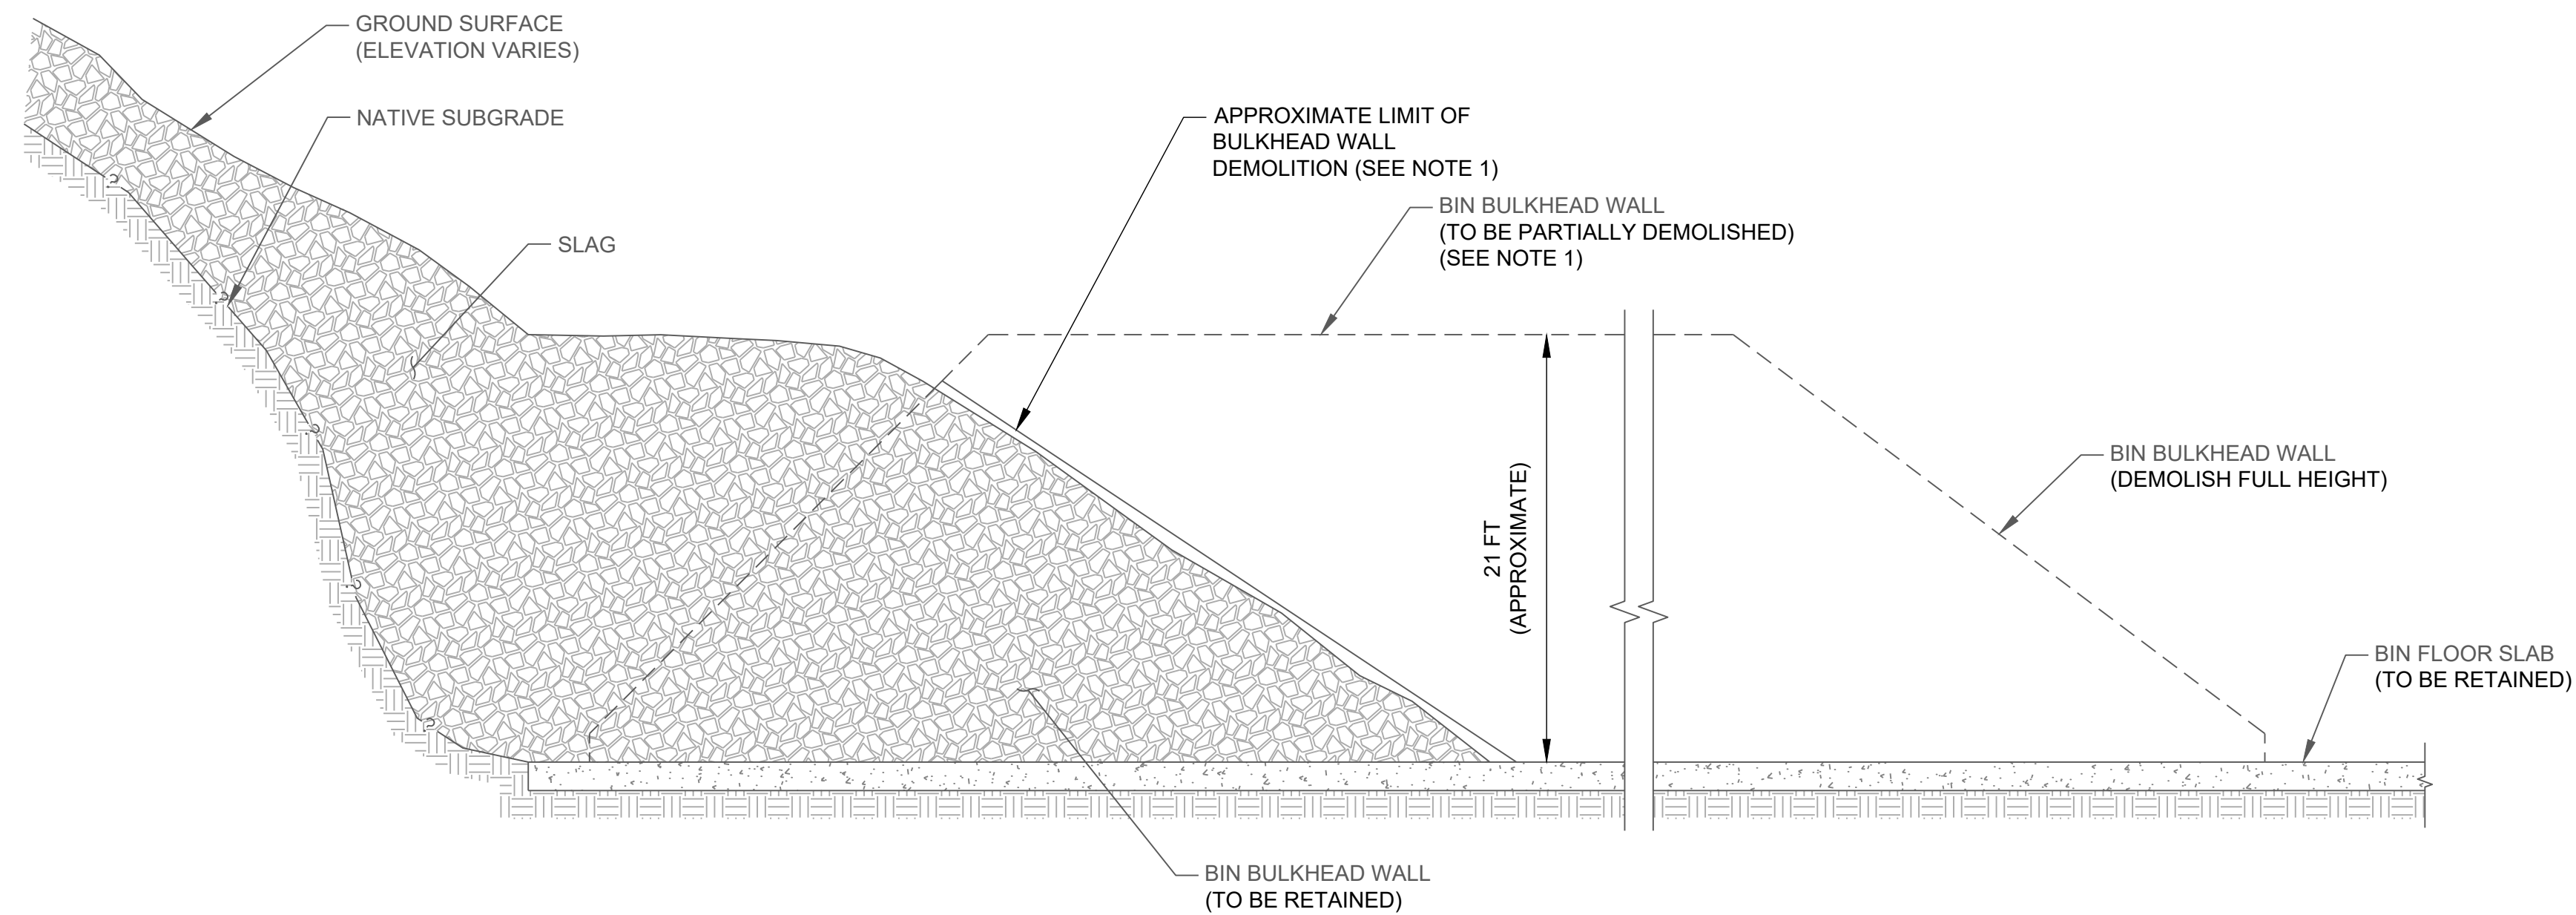
SCALE NTS **G** SOUTH BINS WALL DEMOLITION - TYPICAL SECTION
IAR-240
