# *Request for Section 404 Jurisdictional Determination*

Prepared for    **Cyprus Amax Minerals Company**  
333 North Central Avenue  
Phoenix, Arizona 85004  
602-366-8270

This document is a request for a Section 404 Jurisdictional Determination (JD) for the former Satralloy Facility, located in Cross Creek Township, Jefferson County, Ohio (the Site). The Site is undergoing site investigation work that may require a nationwide permit from the U.S. Army Corps of Engineers (USACE) (Nationwide Permit No. 38, Cleanup of Hazardous and Toxic Waste). A JD was originally issued for the Site on August 6, 2007 and expired on August 6, 2012. Based on that expiration and planned upcoming work, a new JD is required to determine the aquatic resource areas that are currently considered jurisdictional under USACE regulations. This JD request provides the technical documentation required for the USACE to make a determination on the jurisdictional status of the wetlands and waterways on the Site and certain adjoining property that, in total, constitute the Project Area (Figure 1). We request that the USACE review and concur with the identification and delineation of the Waters of the United State

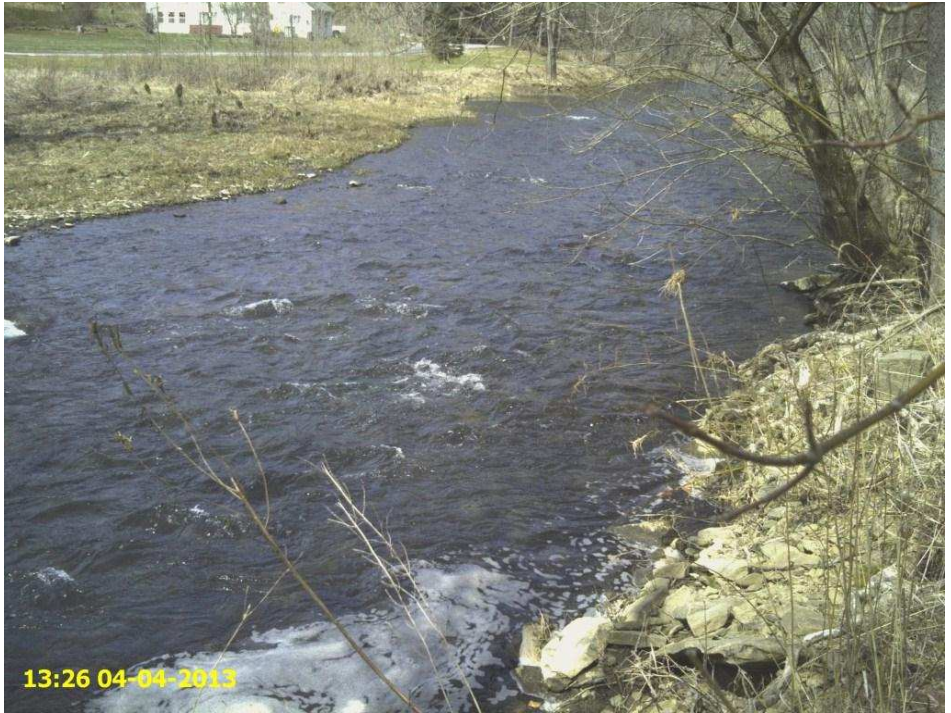
<b>Vanasse Hangen Brustlin, Inc.</b>		<b>PHOTOGRAPHIC LOG</b>	
<b>Client Name:</b> Cyprus		<b>Site Location:</b> Former Satralloy Site	<b>Project No:</b> 11226.02
<b>Photo No. :</b> 1	<b>Date:</b> 4/4/13

<b>Description:</b> Waterway A (Cross Creek), at bend in creek, looking north.

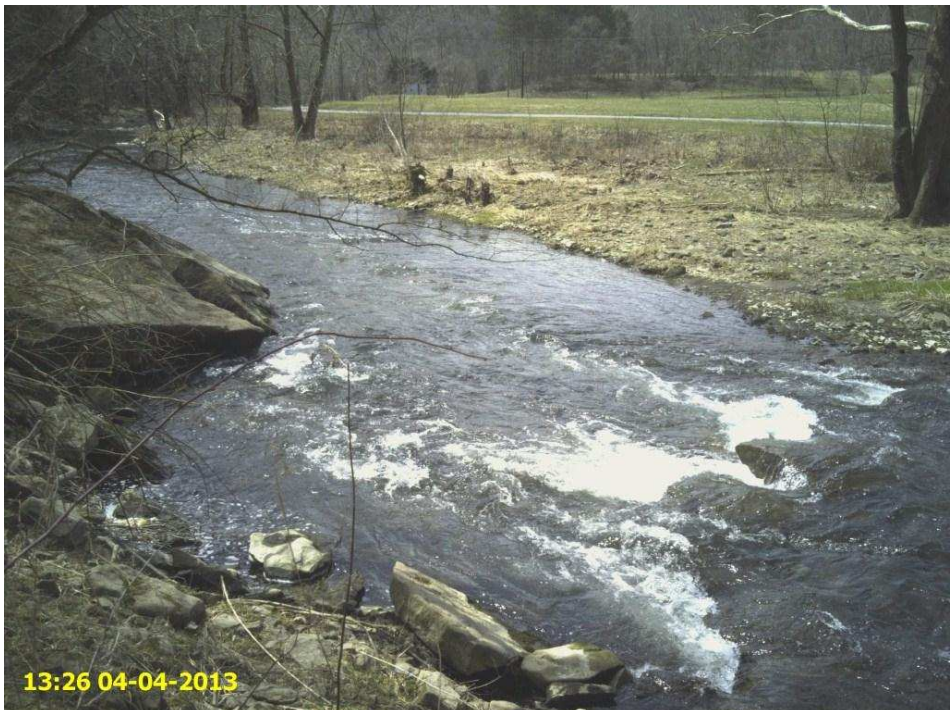
<b>Vanasse Hangen Brustlin, Inc.</b>		<b>PHOTOGRAPHIC LOG</b>	
<b>Client Name:</b> Cyprus		<b>Site Location:</b> Former Satralloy Site	<b>Project No:</b> 11226.02
<b>Photo No. :</b> 2	<b>Date:</b> 4/4/13

<b>Description:</b> Waterway A (Cross Creek), at bend in creek, looking southwest.

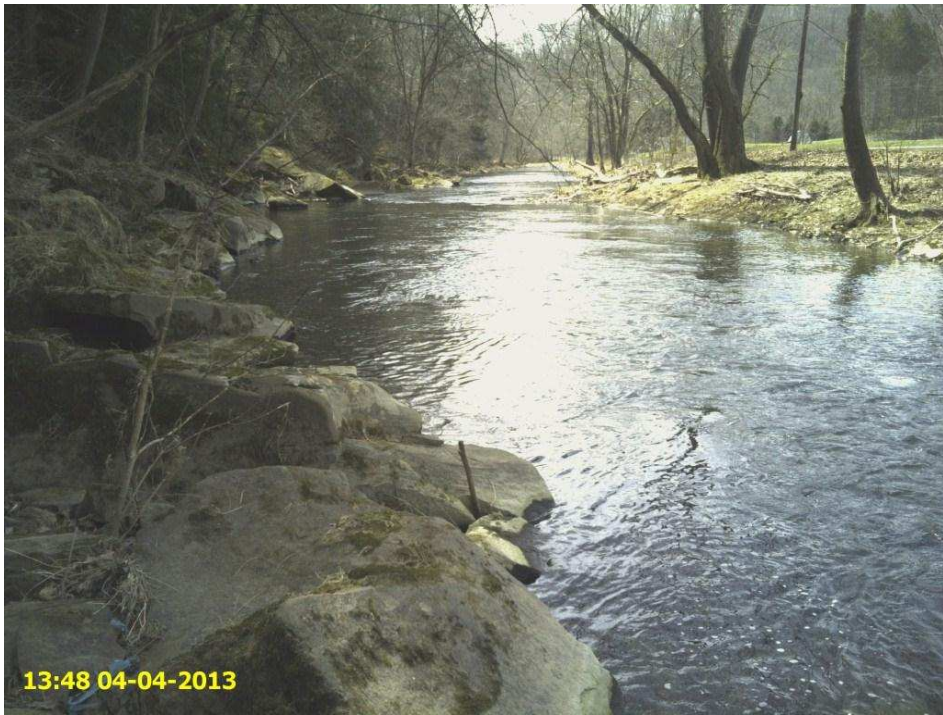
<b>Vanasse Hangen Brustlin, Inc.</b>		<b>PHOTOGRAPHIC LOG</b>	
<b>Client Name:</b> Cyprus		<b>Site Location:</b> Former Satralloy Site	<b>Project No:</b> 11226.02
<b>Photo No. :</b> 3	<b>Date:</b> 4/4/13

<b>Description:</b> Waterway A (Cross Creek), looking southwest.

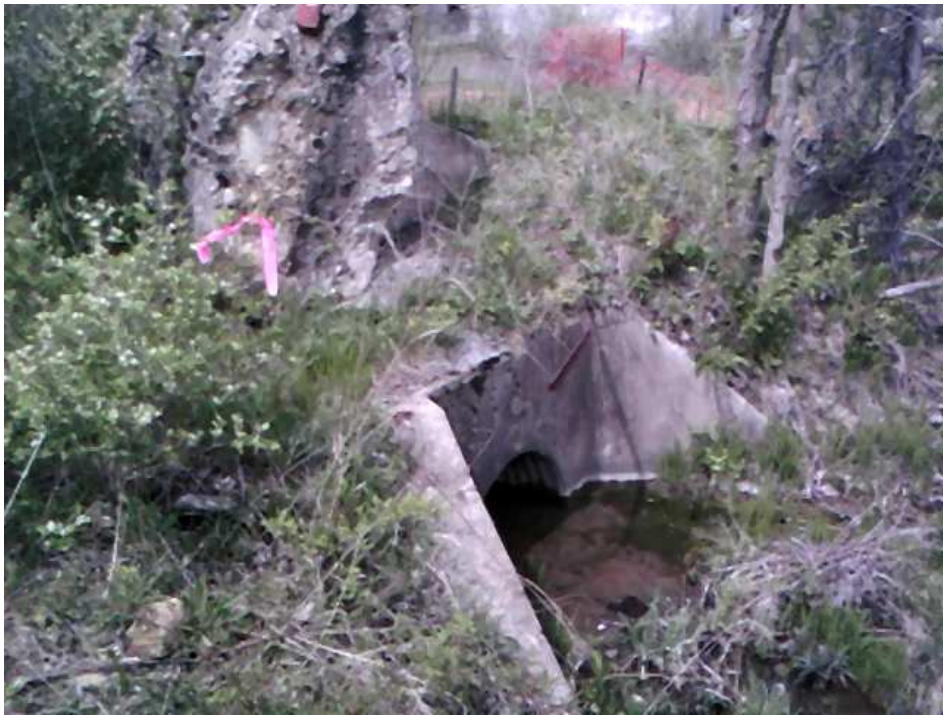
<b>Vanasse Hangen Brustlin, Inc.</b>		<b>PHOTOGRAPHIC LOG</b>	
<b>Client Name:</b> Cyprus		<b>Site Location:</b> Former Satralloy Site	
<b>Project No:</b> 11226.02			
<b>Photo No. :</b> 5	<b>Date:</b> 4/24/12

<b>Description:</b> Wetland D, culvert and headwall at northwestern end, looking northeast.

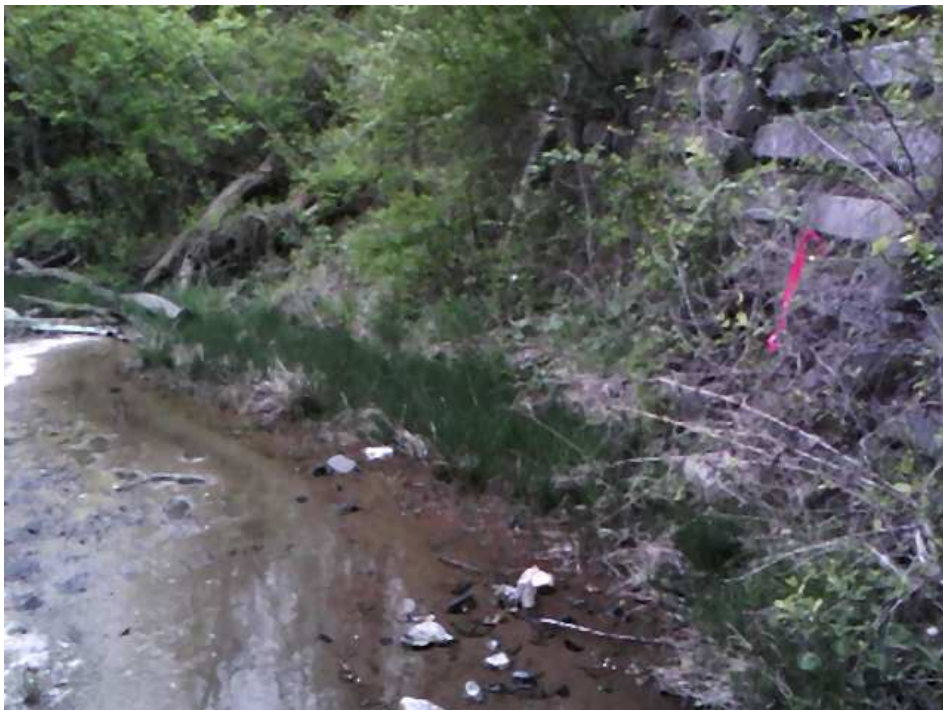
<b>Vanasse Hangen Brustlin, Inc.</b>		<b>PHOTOGRAPHIC LOG</b>	
<b>Client Name:</b> Cyprus		<b>Site Location:</b> Former Satralloy Site	
<b>Project No:</b> 11226.02			
<b>Photo No. :</b> 6	<b>Date:</b> 4/24/12

<b>Description:</b> Wetland E, at northern end of wetland, looking south.

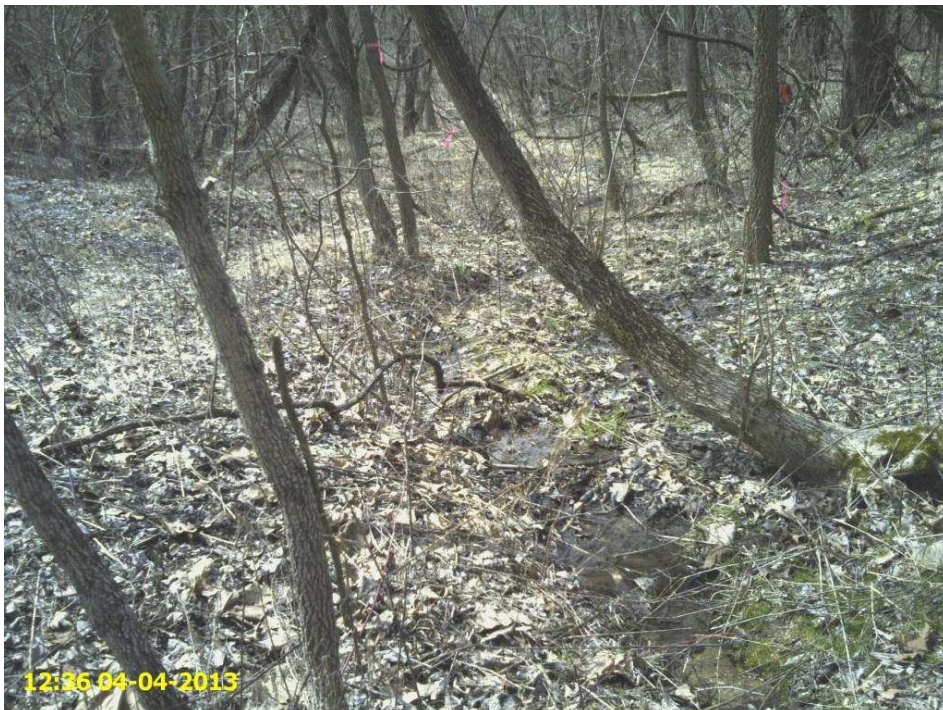
<b>Vanasse Hangen Brustlin, Inc.</b>		<b>PHOTOGRAPHIC LOG</b>	
<b>Client Name:</b> Cyprus		<b>Site Location:</b> Former Satralloy Site	
<b>Project No:</b> 11226.02			
<b>Photo No. :</b> 8	<b>Date:</b> 4/4/13

<b>Description:</b> Wetland/Waterway F, at northeastern end of vegetated wetland, looking southwest.

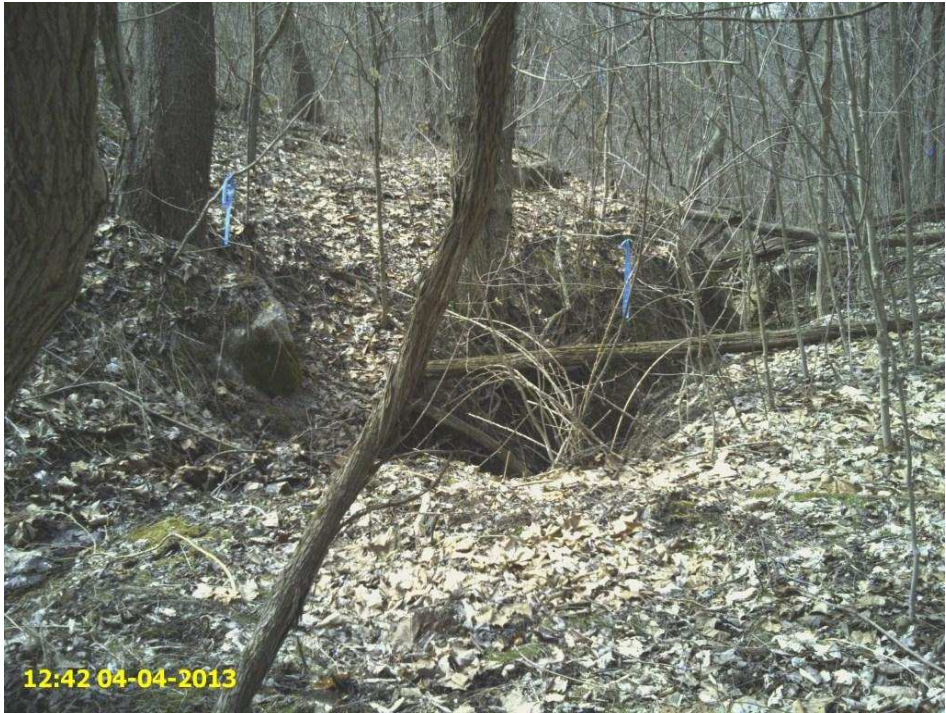
<b>Vanasse Hangen Brustlin, Inc.</b>		<b>PHOTOGRAPHIC LOG</b>	
<b>Client Name:</b> Cyprus		<b>Site Location:</b> Former Satralloy Site	
<b>Project No:</b> 11226.02			
<b>Photo No. :</b> 9	<b>Date:</b> 4/4/13

<b>Description:</b> Wetland/Waterway F, flow from vegetated wetland dropping into well-defined channel, looking southwest.

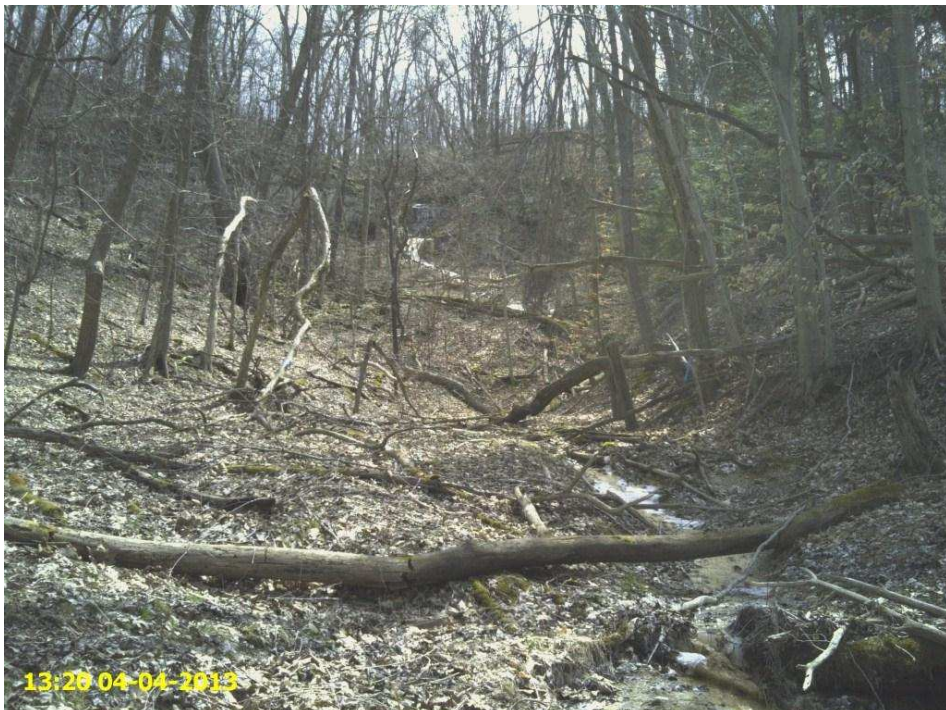
<b>Vanasse Hangen Brustlin, Inc.</b>		<b>PHOTOGRAPHIC LOG</b>	
<b>Client Name:</b> Cyprus		<b>Site Location:</b> Former Satralloy Site	
<b>Project No:</b> 11226.02			
<b>Photo No. :</b> 10	<b>Date:</b> 4/4/13

<b>Description:</b> Wetland/Waterway F, near bottom of channel, looking southeast.

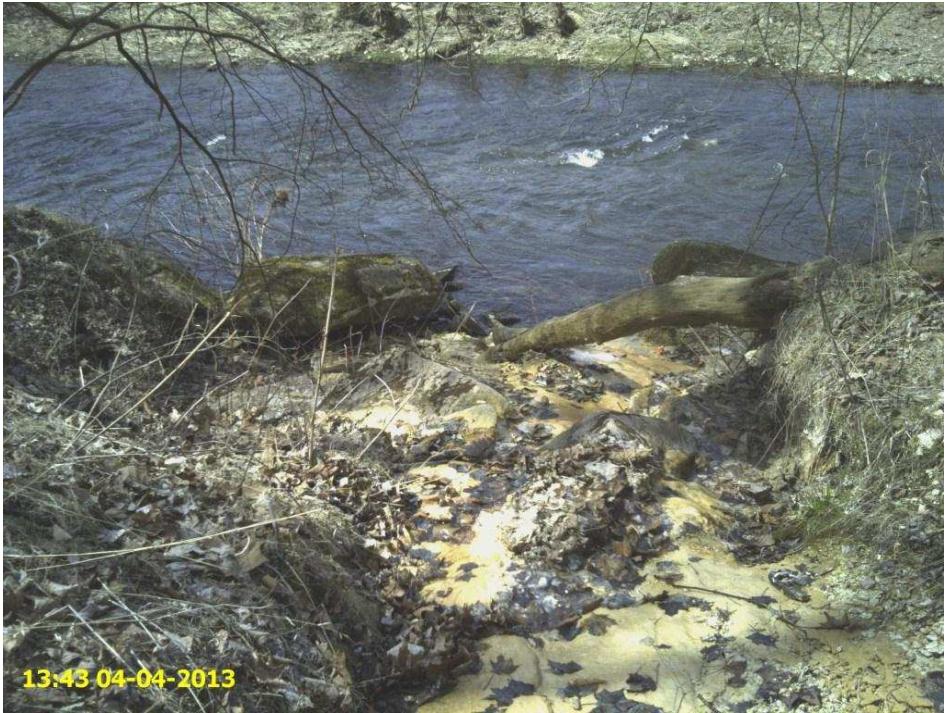
<b>Vanasse Hangen Brustlin, Inc.</b>		<b>PHOTOGRAPHIC LOG</b>	
<b>Client Name:</b> Cyprus		<b>Site Location:</b> Former Satralloy Site	
<b>Project No:</b> 11226.02			
<b>Photo No. :</b> 11	<b>Date:</b> 4/4/13

<b>Description:</b> Wetland/Waterway F, at intersection with Waterway A (Cross Creek), looking northwest.

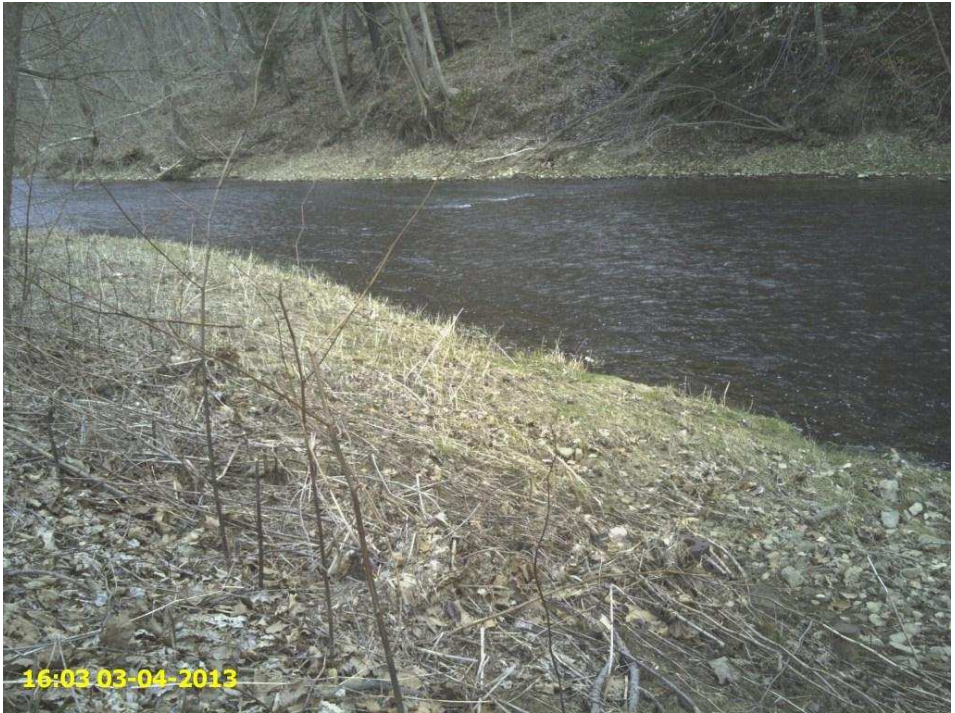
<b>Vanasse Hangen Brustlin, Inc.</b>		<b>PHOTOGRAPHIC LOG</b>	
<b>Client Name:</b> Cyprus		<b>Site Location:</b> Former Satralloy Site	<b>Project No:</b> 11226.02
<b>Photo No. :</b> 13	<b>Date:</b> 4/3/13

<b>Description:</b> Waterway H (Cross Creek), at southern property boundary, looking northeast.

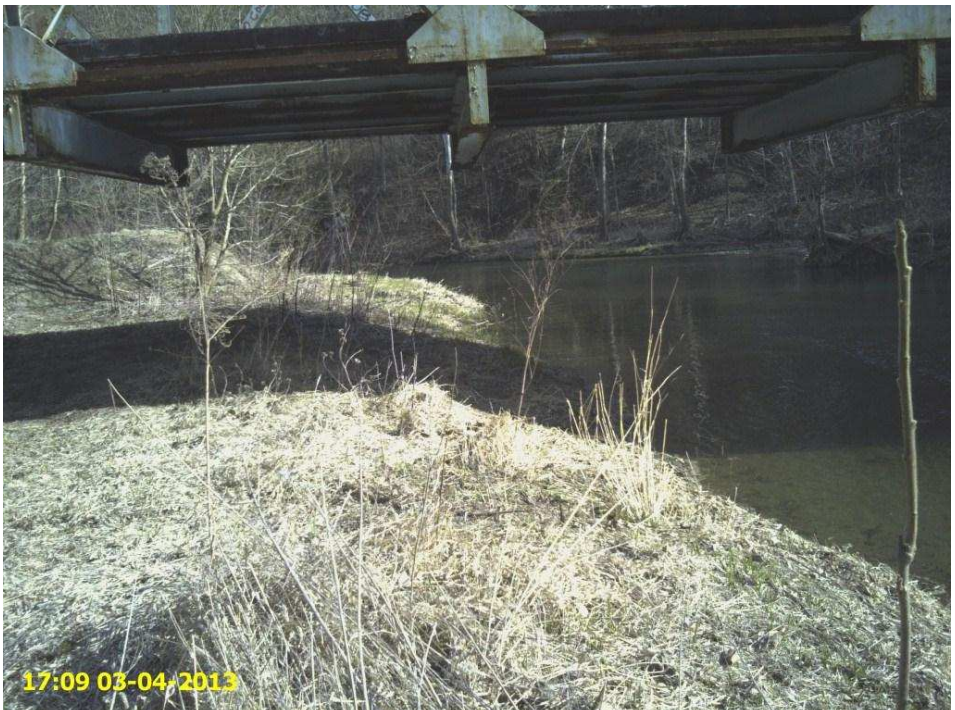
<b>Vanasse Hangen Brustlin, Inc.</b>		<b>PHOTOGRAPHIC LOG</b>	
<b>Client Name:</b> Cyprus		<b>Site Location:</b> Former Satralloy Site	<b>Project No:</b> 11226.02
<b>Photo No. :</b> 14	<b>Date:</b> 4/3/13

<b>Description:</b> Waterway H (Cross Creek), at bridge by western property border, looking south.

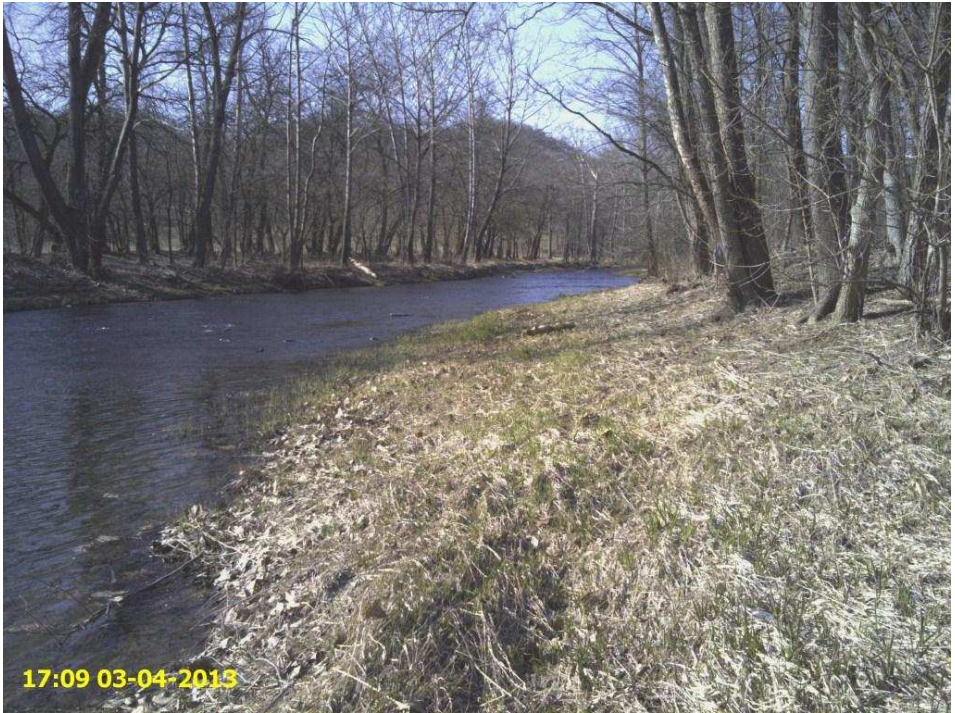
<b>Vanasse Hangen Brustlin, Inc.</b>		<b>PHOTOGRAPHIC LOG</b>	
<b>Client Name:</b> Cyprus		<b>Site Location:</b> Former Satralloy Site	
<b>Project No:</b> 11226.02			
<b>Photo No. :</b> 15	<b>Date:</b> 4/3/13

<b>Description:</b> Waterway H (Cross Creek), at bridge by western property border, looking north.

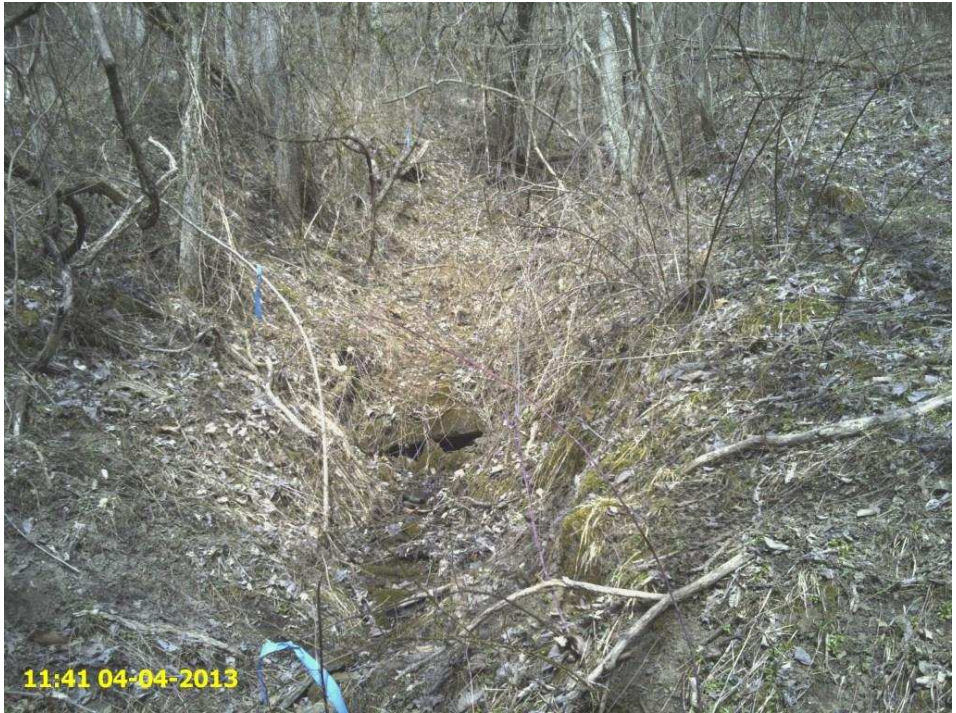
<b>Vanasse Hangen Brustlin, Inc.</b>		<b>PHOTOGRAPHIC LOG</b>	
<b>Client Name:</b> Cyprus		<b>Site Location:</b> Former Satralloy Site	<b>Project No:</b> 11226.02
<b>Photo No. :</b> 17	<b>Date:</b> 4/4/13

<b>Description:</b> Wetland/Waterway J, at southern end of wetland, looking north.

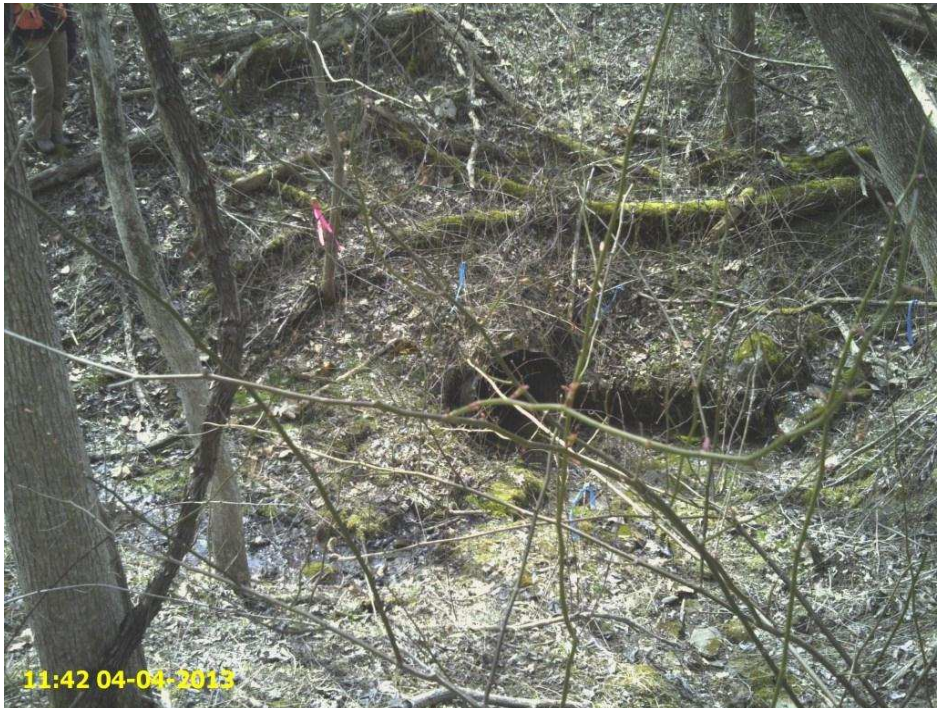
<b>Vanasse Hangen Brustlin, Inc.</b>		<b>PHOTOGRAPHIC LOG</b>	
<b>Client Name:</b> Cyprus		<b>Site Location:</b> Former Satralloy Site	<b>Project No:</b> 11226.02
<b>Photo No. :</b> 18	<b>Date:</b> 4/4/13

<b>Description:</b> Wetland/Waterway J, culvert at southern end, looking southwest.

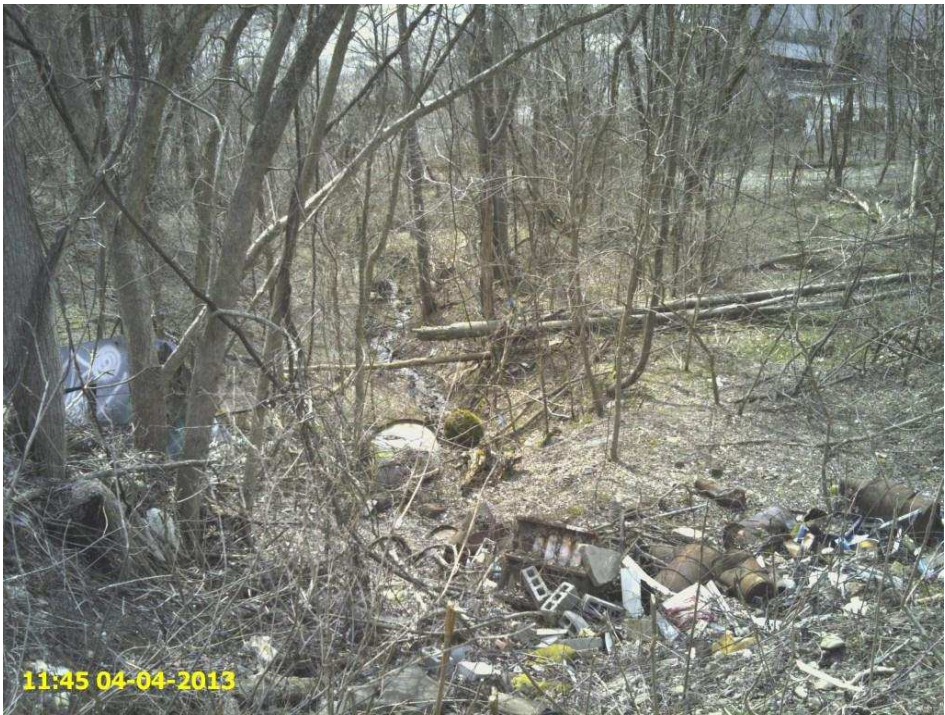
<b>Vanasse Hangen Brustlin, Inc.</b>		<b>PHOTOGRAPHIC LOG</b>	
<b>Client Name:</b> Cyprus		<b>Site Location:</b> Former Satralloy Site	
<b>Project No:</b> 11226.02			
<b>Photo No. :</b> 19	<b>Date:</b> 4/4/13

<b>Description:</b> Waterway K, from access road separating Wetlands J and K, looking southeast.

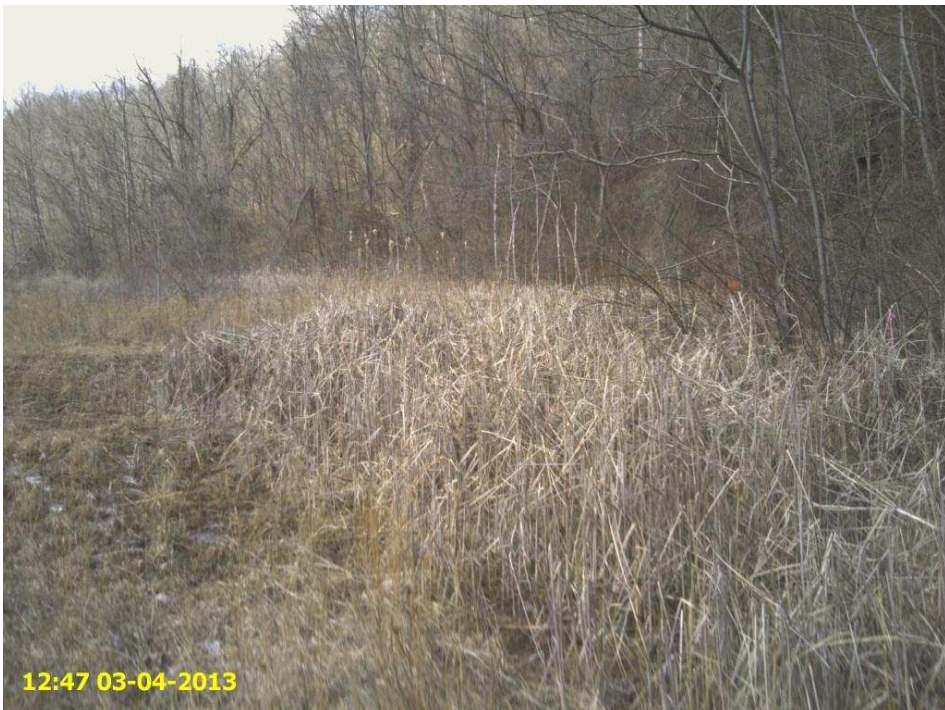
<b>Vanasse Hangen Brustlin, Inc.</b>		<b>PHOTOGRAPHIC LOG</b>	
<b>Client Name:</b> Cyprus		<b>Site Location:</b> Former Satralloy Site	
<b>Project No:</b> 11226.02			
<b>Photo No. :</b> 20	<b>Date:</b> 4/3/13

Wetland P is a palustrine emergent wetland that has formed in the area where the upper rail spur into the Site was located when the smelting facility was still functional. The rails and ties of the spur have been removed; Wetland P has formed on the remaining flat rail bed and surrounding area. Water flows from this area down a manmade drainage ditch alongside the path of the rail spur toward the existing Norfolk and Western Railroad. The drainage ditch has degraded over time and has filled in partially, becoming a palustrine emergent vegetated swale. Water then flows through a culvert under the rail bed and into Wetland EE, where it dissipates into the ground.

<b>Description:</b> Wetland P, at edge of former rail spur, looking west.

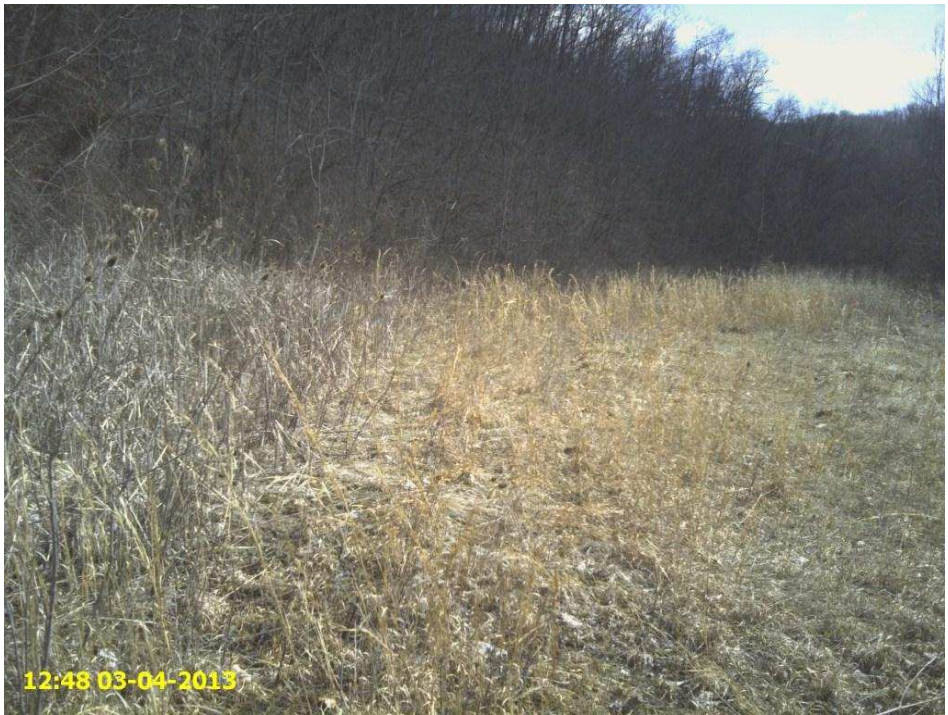
<b>Vanasse Hangen Brustlin, Inc.</b>		<b>PHOTOGRAPHIC LOG</b>	
<b>Client Name:</b> Cyprus		<b>Site Location:</b> Former Satralloy Site	<b>Project No:</b> 11226.02
<b>Photo No. :</b> 21	<b>Date:</b> 4/3/13

<b>Description:</b> Wetland P, at edge of former rail spur, looking east.

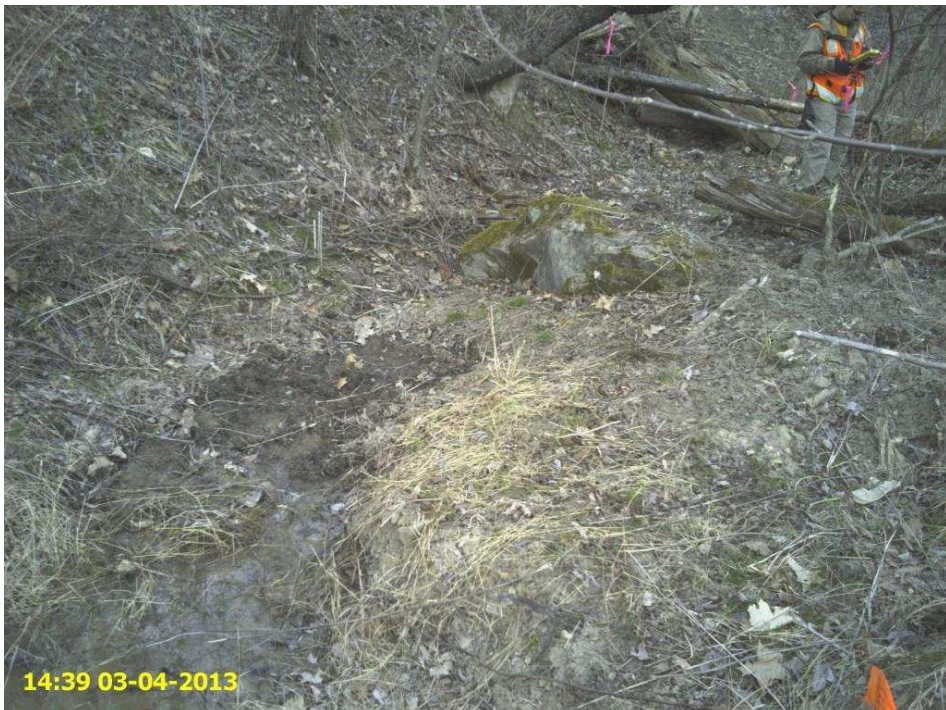
<b>Vanasse Hangen Brustlin, Inc.</b>		<b>PHOTOGRAPHIC LOG</b>	
<b>Client Name:</b> Cyprus		<b>Site Location:</b> Former Satralloy Site	
<b>Project No:</b> 11226.02			
<b>Photo No. :</b> 24	<b>Date:</b> 4/3/13

Wetland Q is a palustrine emergent wetland that, like Wetland P, has formed in the area of the upper rail spur. Wetland Q begins just downgradient of the culvert where water flows from Wetland P into Wetland EE. Wetland Q consists of the same partially degraded drainage ditch along the old rail bed, which has become a palustrine emergent vegetated swale.

<b>Description:</b> Wetland Q, at eastern end of wetland, looking north.

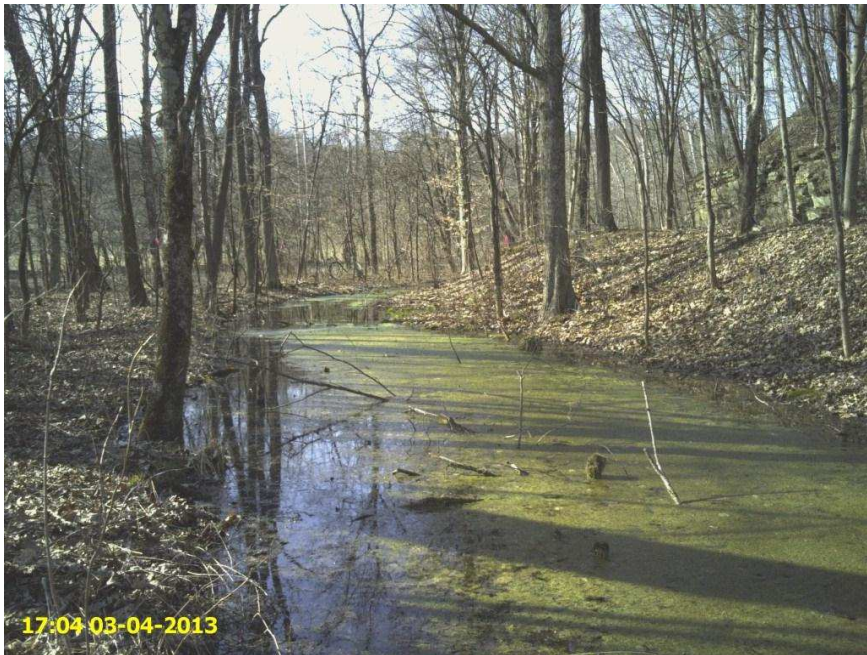
<b>Vanasse Hangen Brustlin, Inc.</b>		<b>PHOTOGRAPHIC LOG</b>	
<b>Client Name:</b> Cyprus		<b>Site Location:</b> Former Satralloy Site	
<b>Project No:</b> 11226.02			
<b>Photo No. :</b> 25	<b>Date:</b> 4/3/13

<b>Description:</b> Wetland YY, at southeastern end of wetland, looking northwest.

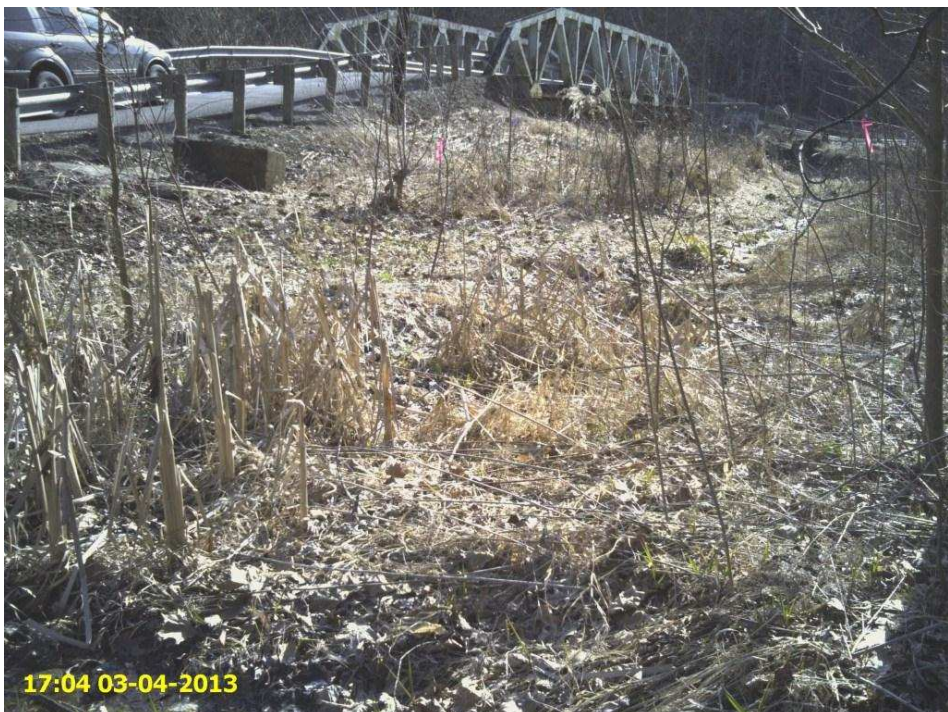
<b>Vanasse Hangen Brustlin, Inc.</b>		<b>PHOTOGRAPHIC LOG</b>	
<b>Client Name:</b> Cyprus		<b>Site Location:</b> Former Satralloy Site	
<b>Project No:</b> 11226.02			
<b>Photo No. :</b> 26	<b>Date:</b> 4/3/13

<b>Description:</b> Wetland YY, at southeastern end of wetland, looking west.
