Stage 2 Interim Action Report for the Former Satralloy Site (Jefferson County, Ohio)

Cyprus Amax Minerals Company

WSP USA Inc.

October 2023

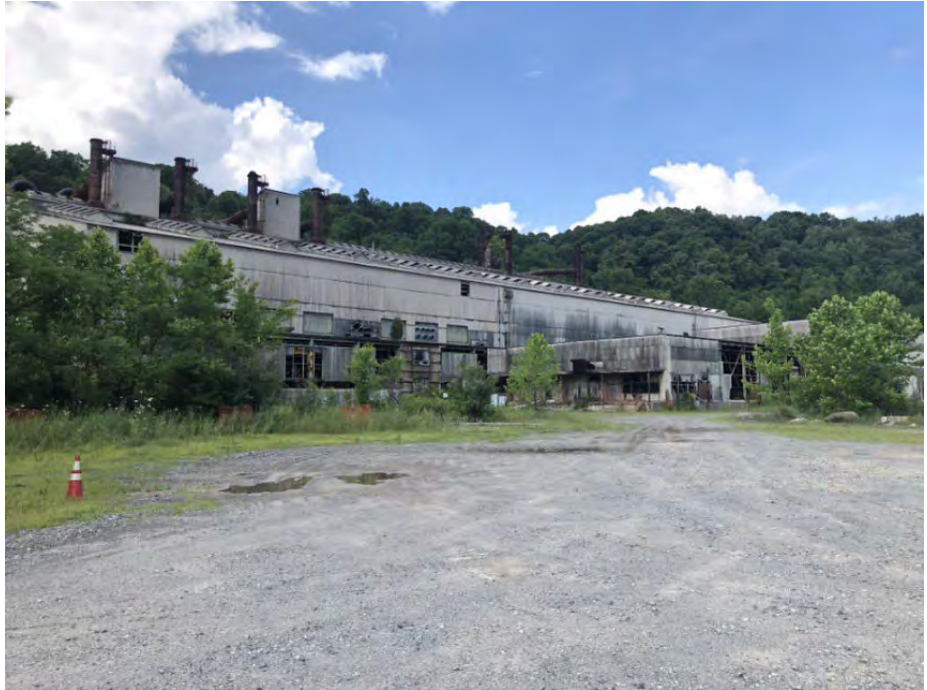
North Mill Building before transite removal and demolition.

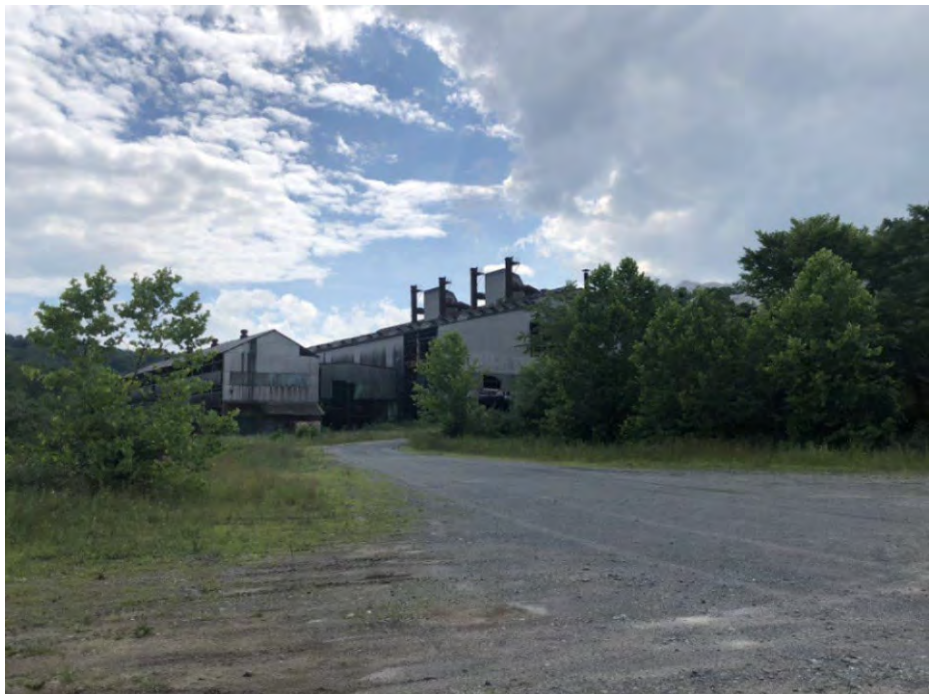
PHOTOGRAPH 2

South Mill Building before transite removal and demolition.

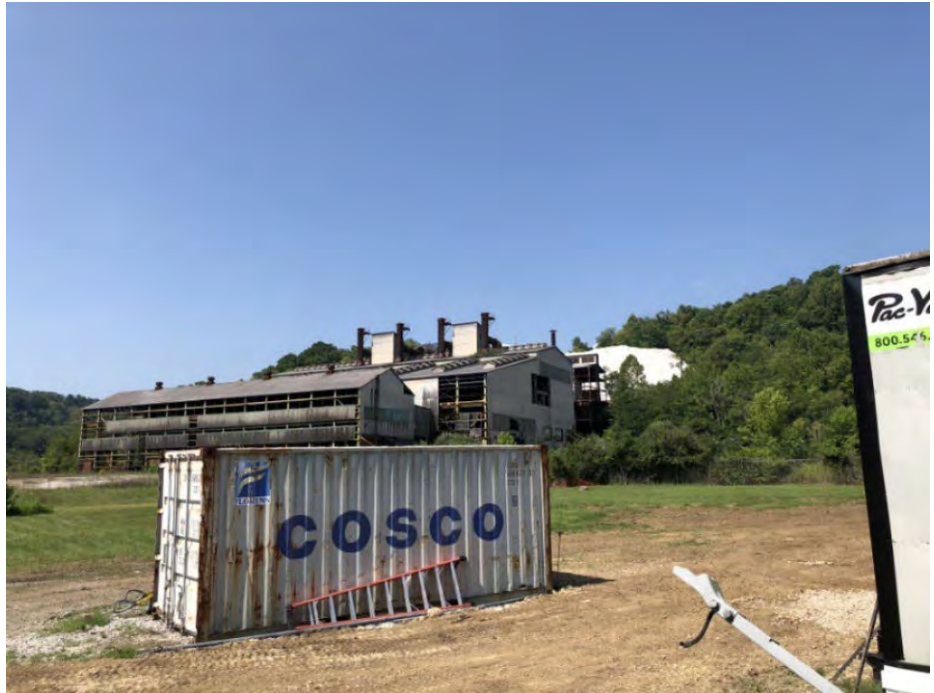
PHOTOGRAPH 3

South Mill Building before transite removal and demolition.

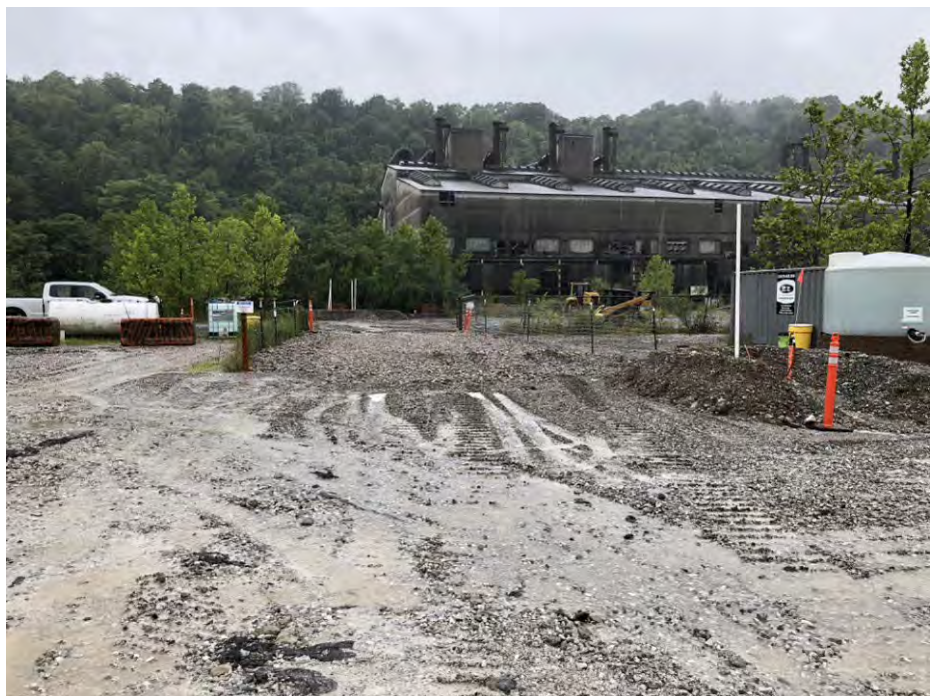
PHOTOGRAPH 4

Decontamination pad and entrance to exclusion zone.

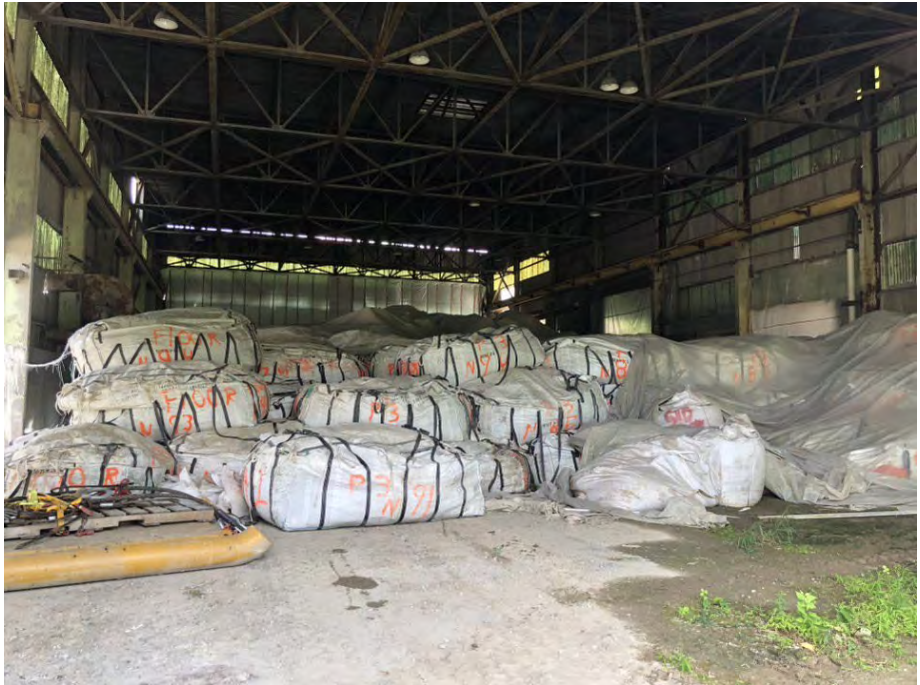
PHOTOGRAPH 5

During handling, many of the previously filled and staged dust bags tore open, with the dust spilling to the high bay floor. This issue was attributed to the age of the bags and weathering and deterioration that resulted from the extended period of time since the bags had been filled. To continue off-site disposal, it became necessary to re-bag much of the dust into new disposal bags. RECON transferred the contents of damaged bags and dust that had spilled to the NMB high bay floor into new 1- and 5-cubic yard bags.

Previously filled bags of chromium-containing dust staged in the high bay of the North Mill Building.

During sorting and re-bagging, some NMB and SMB dust became commingled, and the identity of some previously filled bags could not be determined. Because dust from the NMB was being transported off-site for disposal as hazardous waste, commingled dust and the contents of any unidentifiable bags were managed as hazardous waste. After the re-bagged dust was removed from the NMB high bay, RECON cleaned the floor with a power broom.

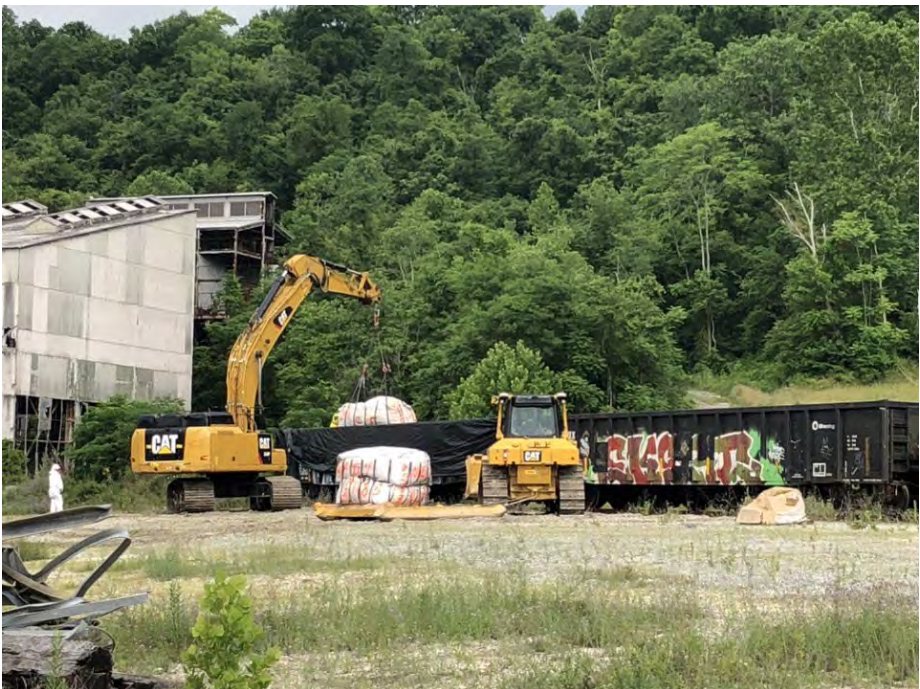
PHOTOGRAPH 6

Loading previously filled dust bags into lined rail gondola.

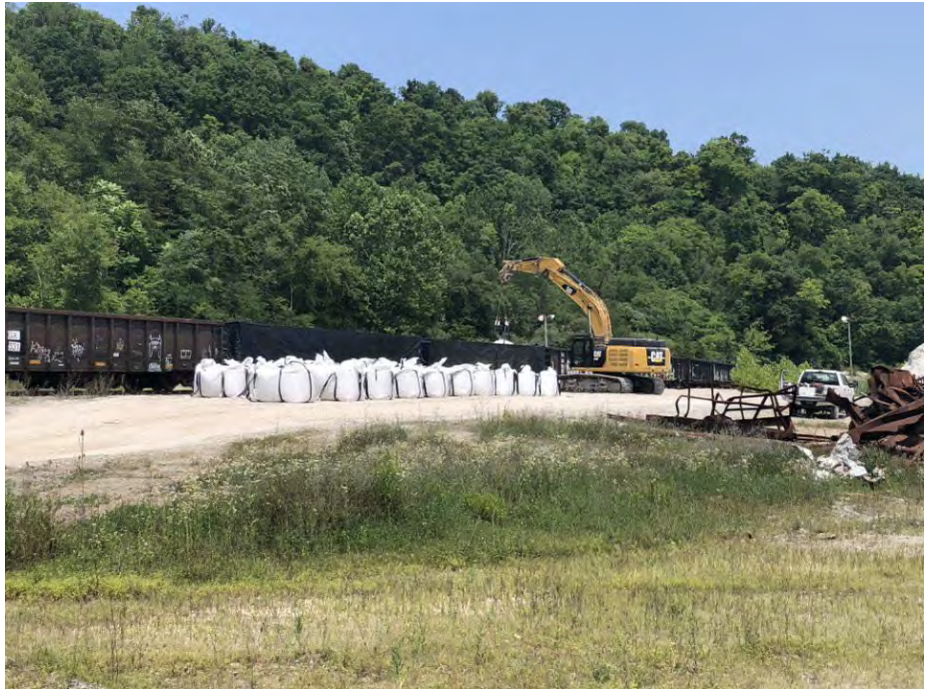
PHOTOGRAPH 7

Loading dust bags into lined rail gondola.

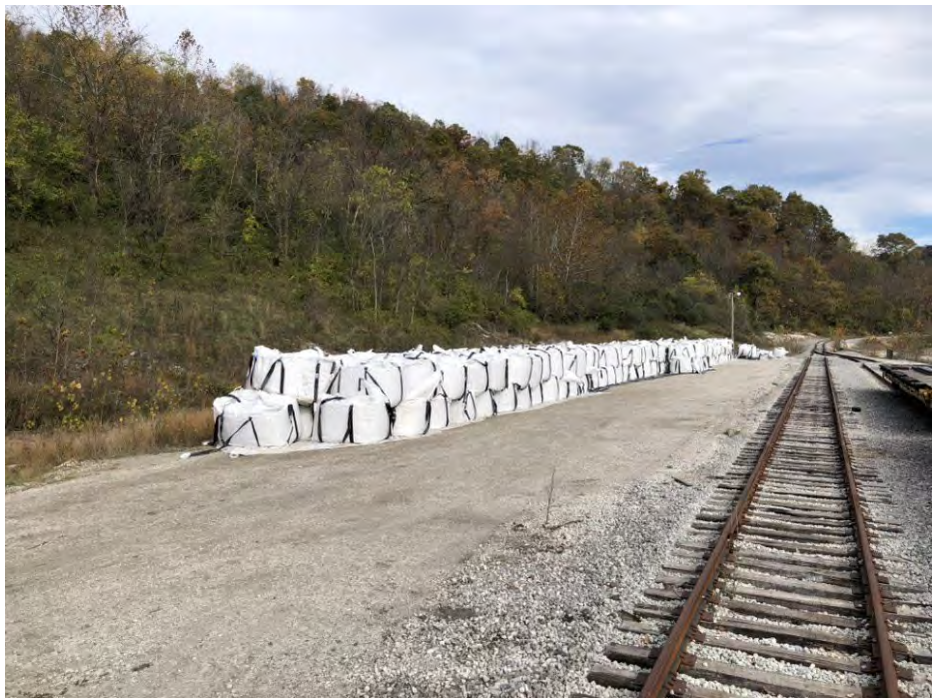
PHOTOGRAPH 8

Newly loaded bags of chromium-containing dust staged by the rail spur.

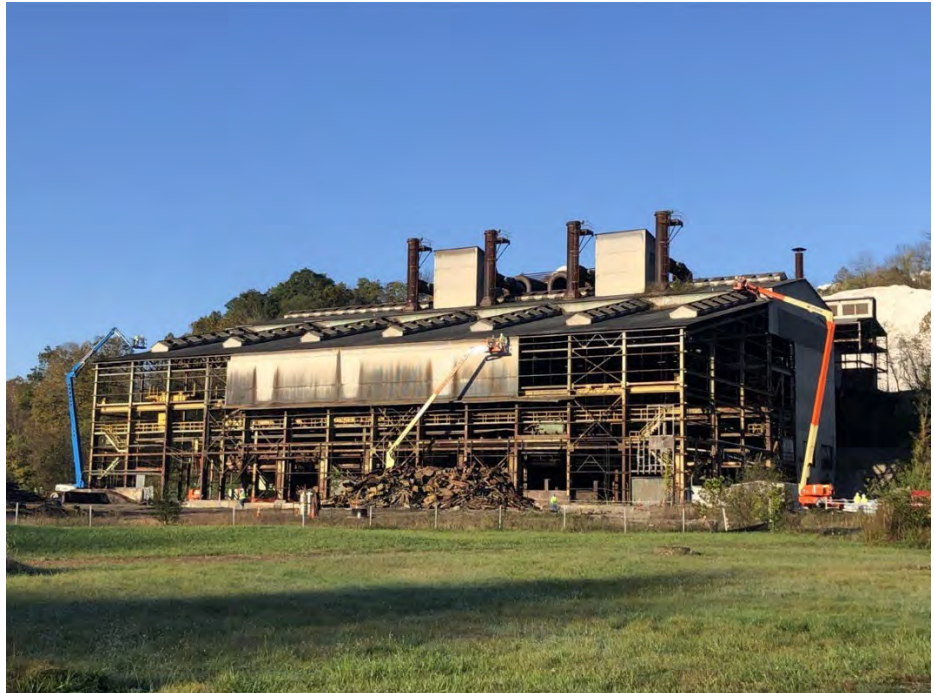
PHOTOGRAPH 9

Removal of transite wall and roof panels from the South Mill Building.

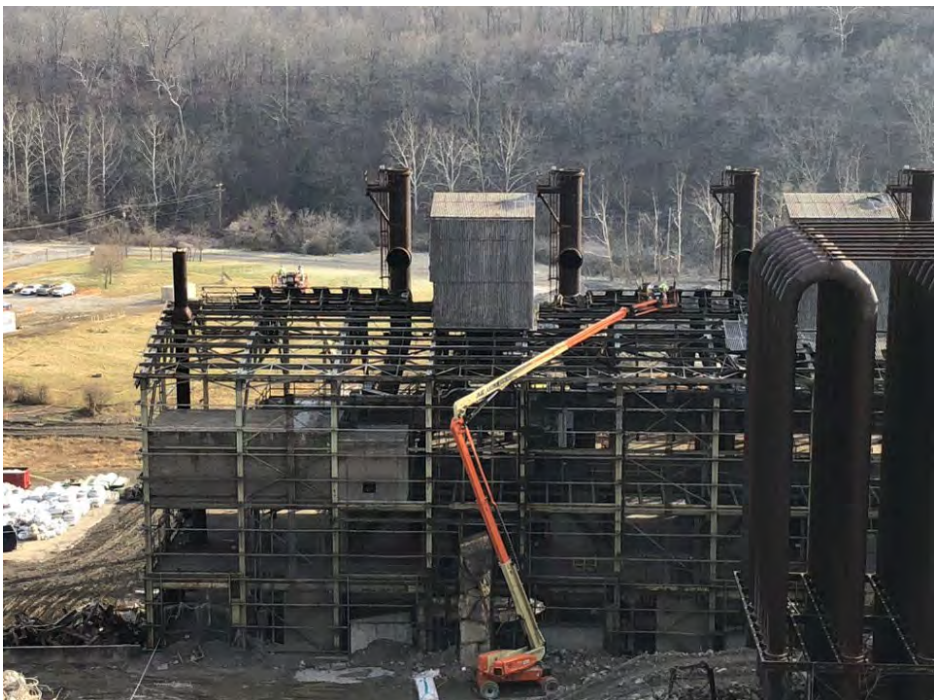
PHOTOGRAPH 10

Removal of transite roof panels from the South Mill Building.

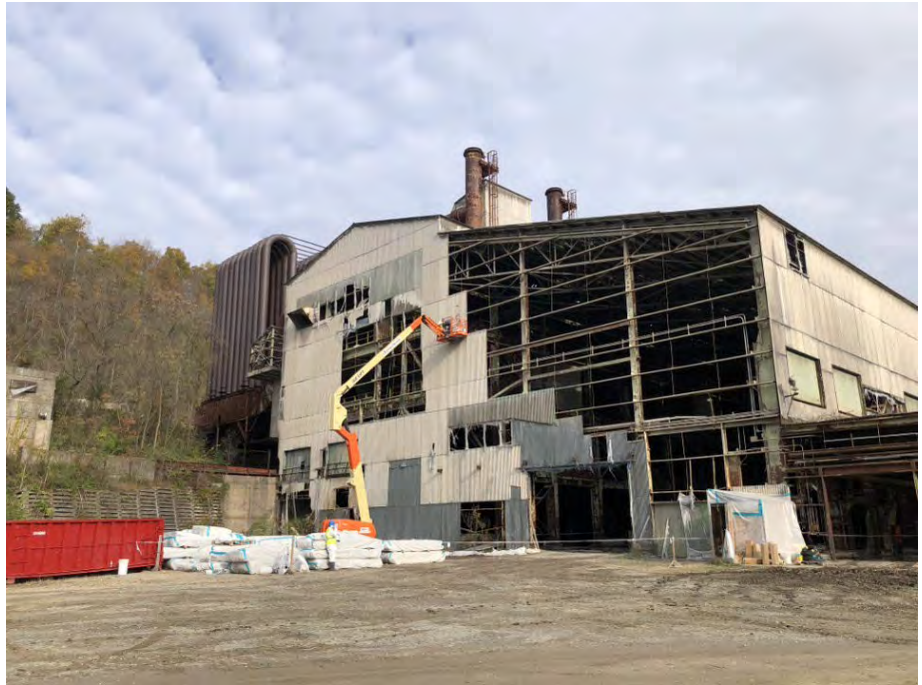
PHOTOGRAPH 11

Removal of transite wall panels from the North Mill Building.

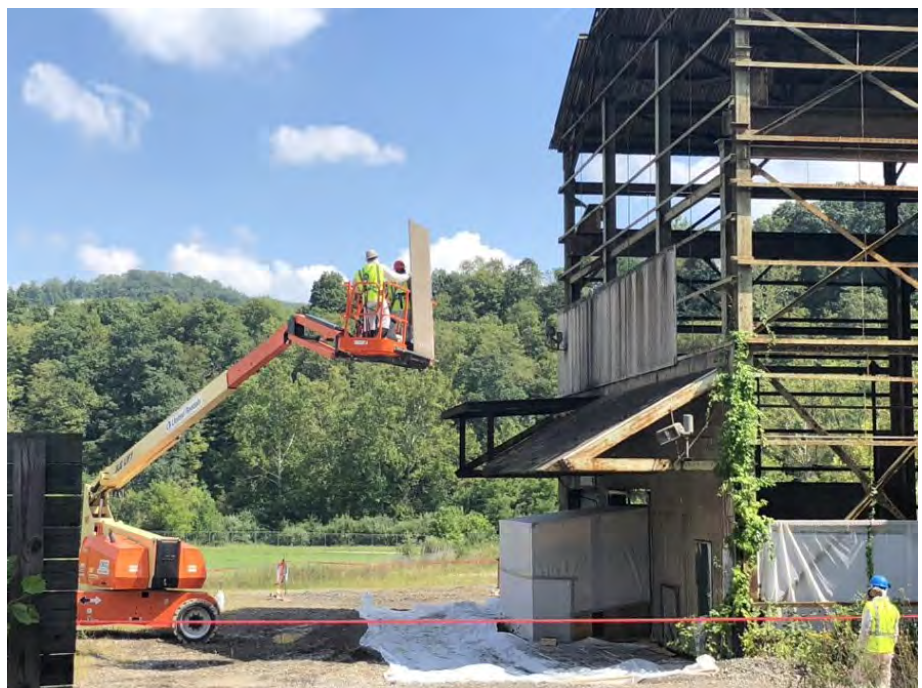
PHOTOGRAPH 12

Using the boom lift with sill plate to remove a transite wall panel from the South Mill Building.

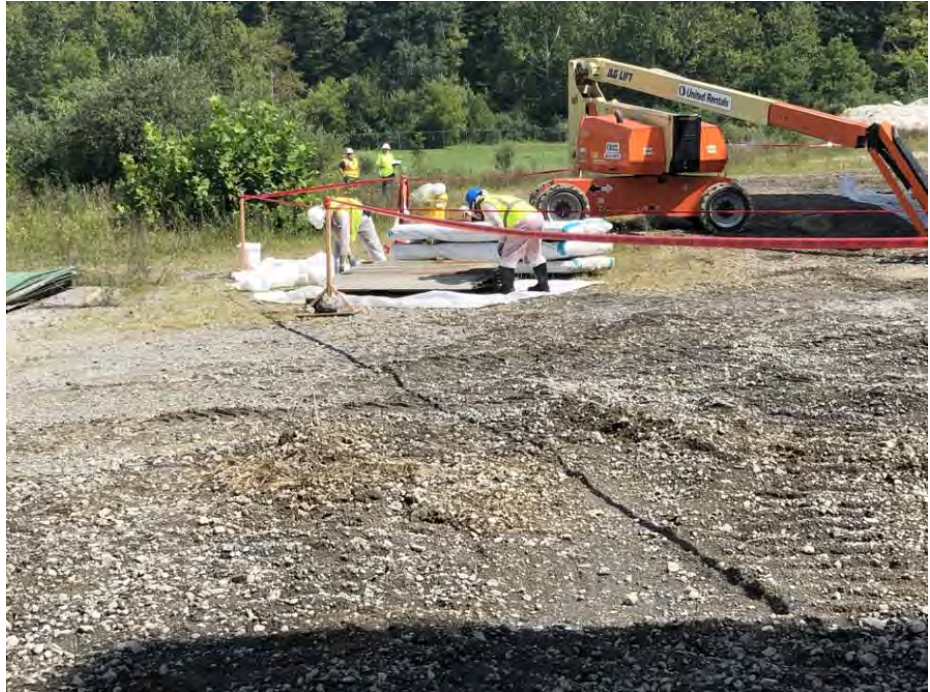
PHOTOGRAPH 13

Stacking transite panels on polyethylene sheeting.

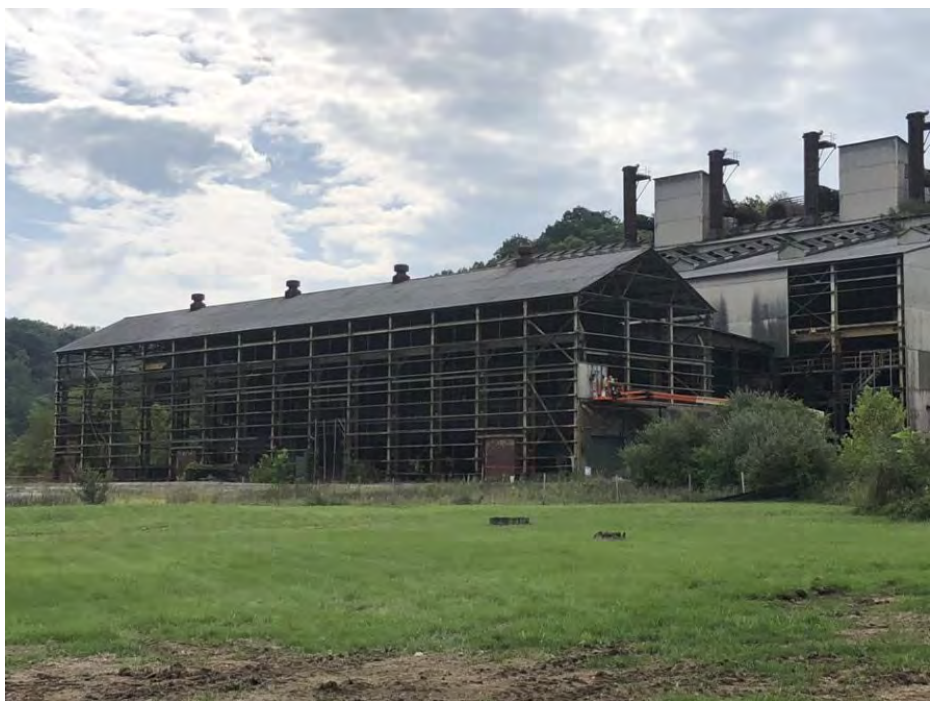
PHOTOGRAPH 14

Transite removal is almost completed from the lower section of the South Mill Building.

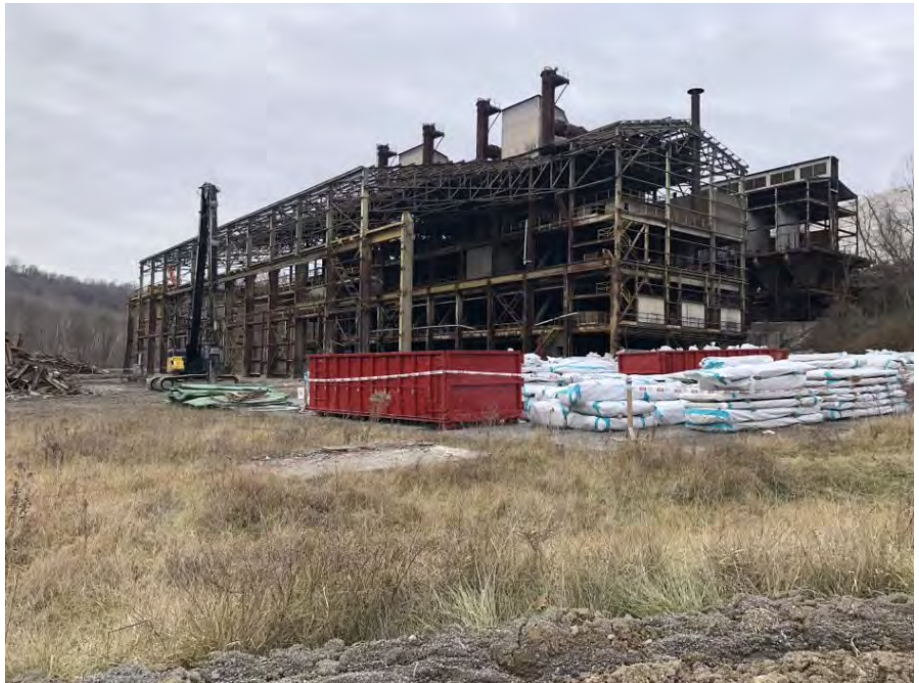
PHOTOGRAPH 15

Polyethylene-wrapped transite bundles and roll-off containers at a waste staging area.

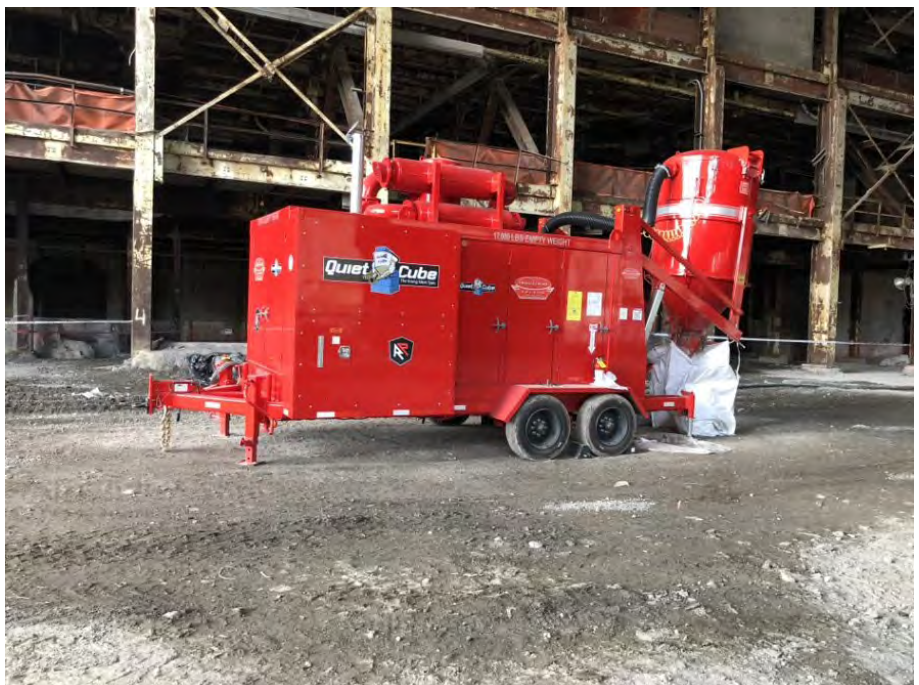
PHOTOGRAPH 16

Prior to the removal of transite panels, the NMB was cleaned of loose chromium-containing dust. The dust was removed by a group of ARC workers using vacuums and other mechanical methods. A trailer-mounted industrial vacuum was used to remove the bulk of the dust from accessible areas of the building. The vacuum box was placed in the casting bay and moved with equipment along the length of the furnace deck. This vacuum box was equipped with long hoses that ARC workers used to access and clean much of the furnace deck and casting bay. As dust was vacuumed by the workers with hoses, it was collected in cubic-yard bags. As each bag was filled with dust, ARC workers closed and secured it and then transported it to the NMB high bay staging area, where it was later loaded by RECON into the US Ecology gondolas (see Section 2.7). In addition to this large vacuum box, ARC workers also used smaller floor and back-carried vacuum units in less accessible areas of the NMB outside the reach of the trailer-mounted vacuum.

Trailer-mounted vacuum for collection of chromium-containing dust from the North Mill Building.

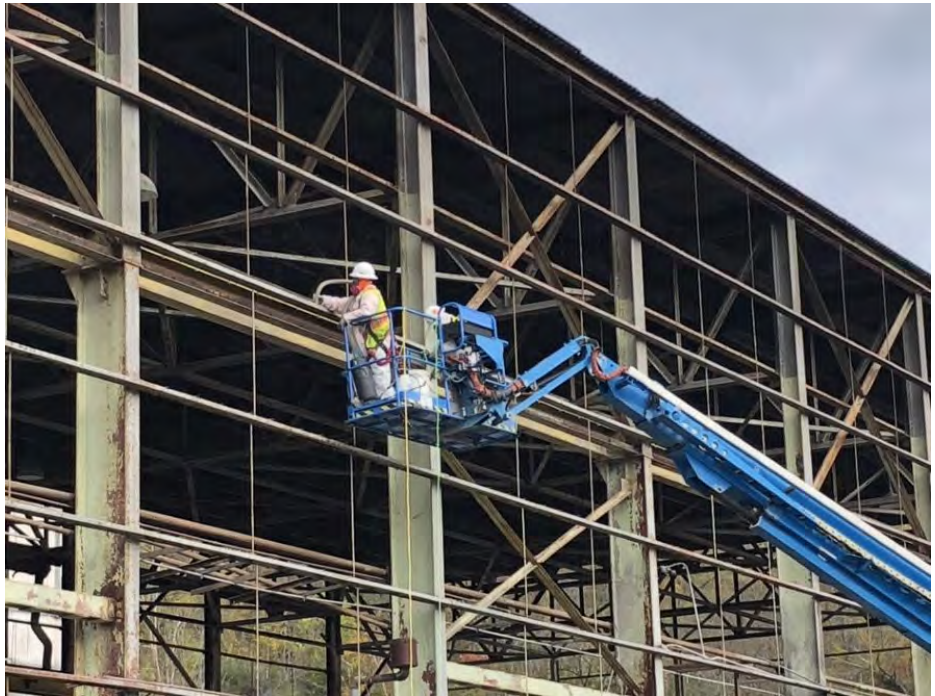
PHOTOGRAPH 17

Vacuuming dust from a beam
at the North Mill Building.

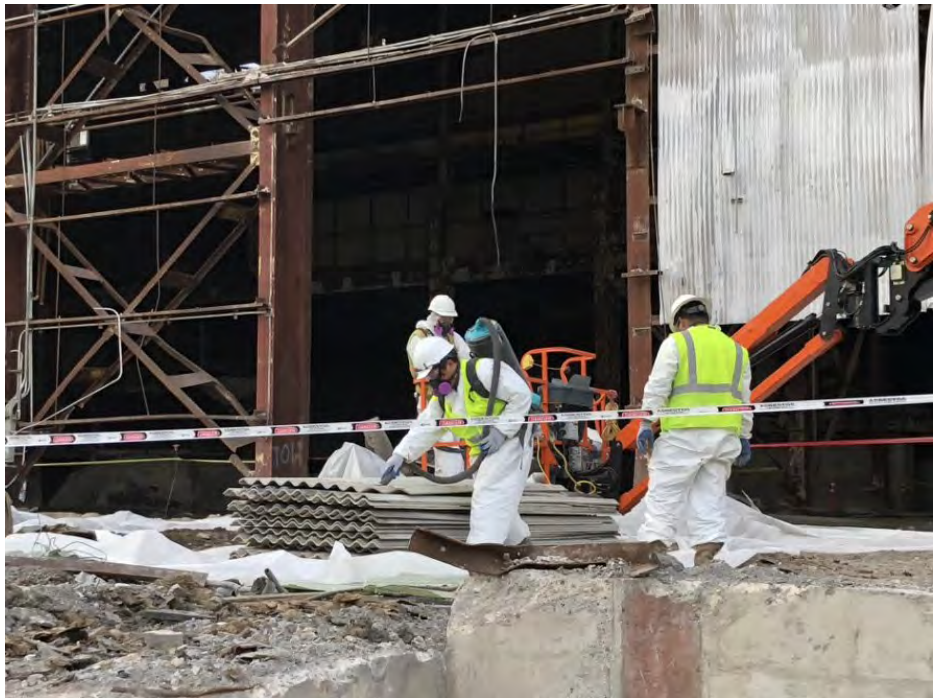
PHOTOGRAPH 18

Vacuuming dust from transite
panels after removal from
the North Mill Building.

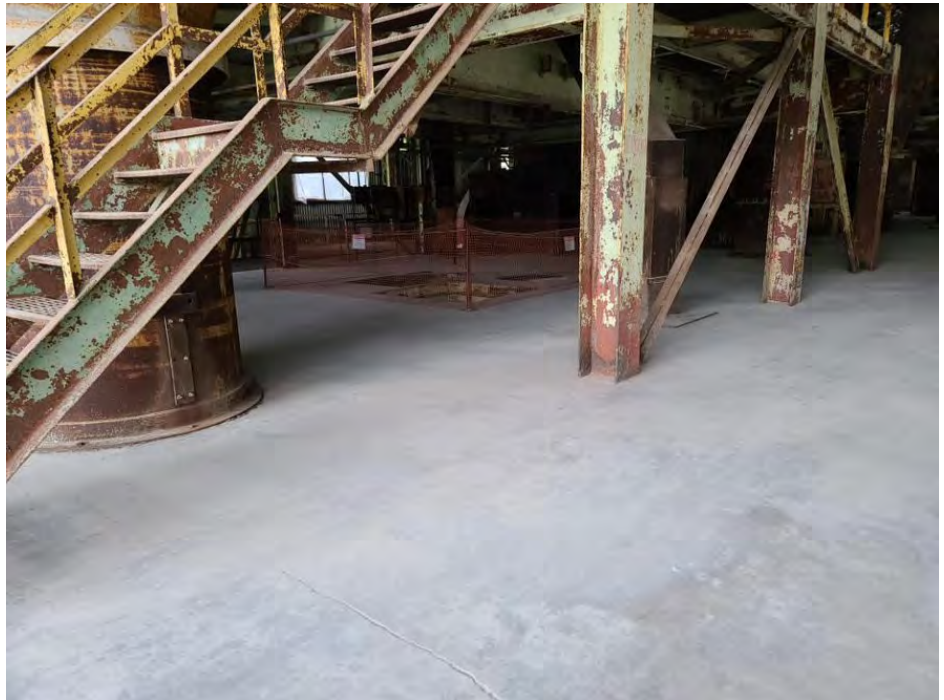
PHOTOGRAPH 19

The North Mill Building after dust cleaning and removal.

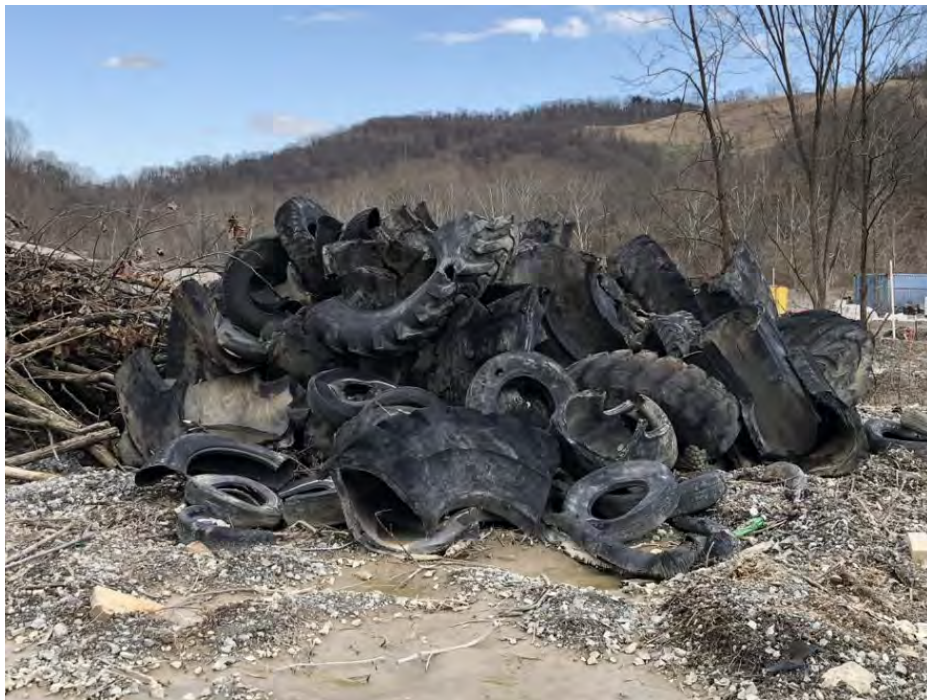
Pile of waste tires.

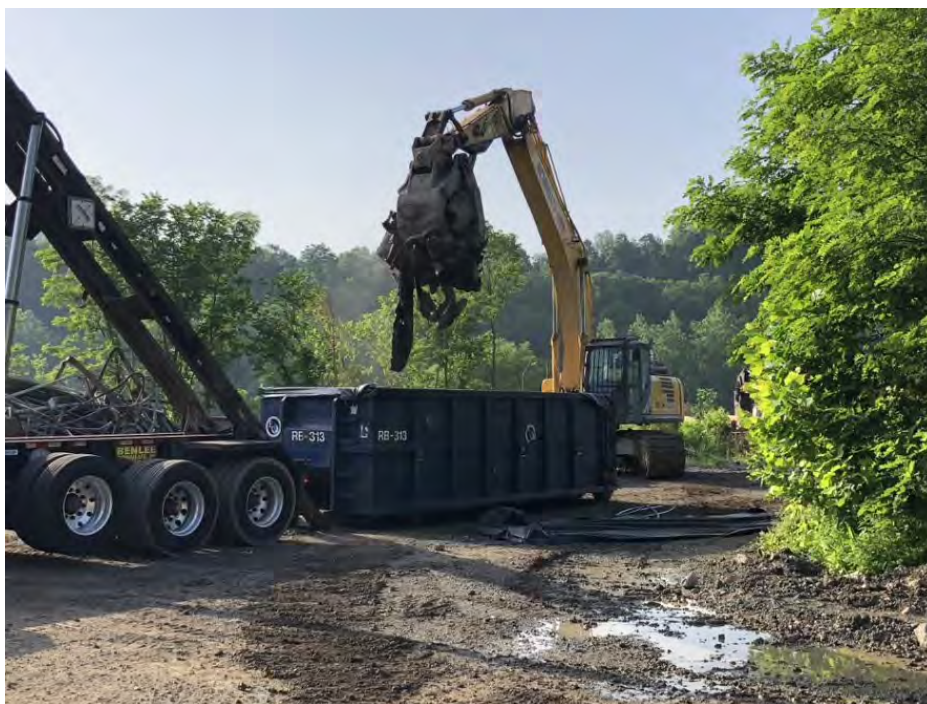
PHOTOGRAPH 22

Loading waste tires into a container for disposal.

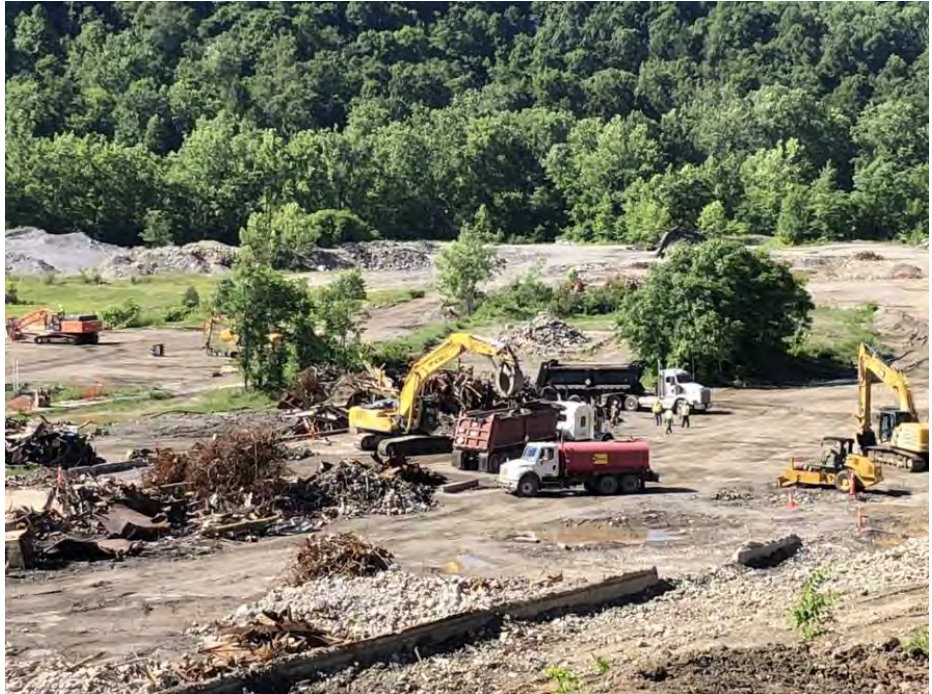
Loading PCB-contaminated concrete into a truck for disposal.

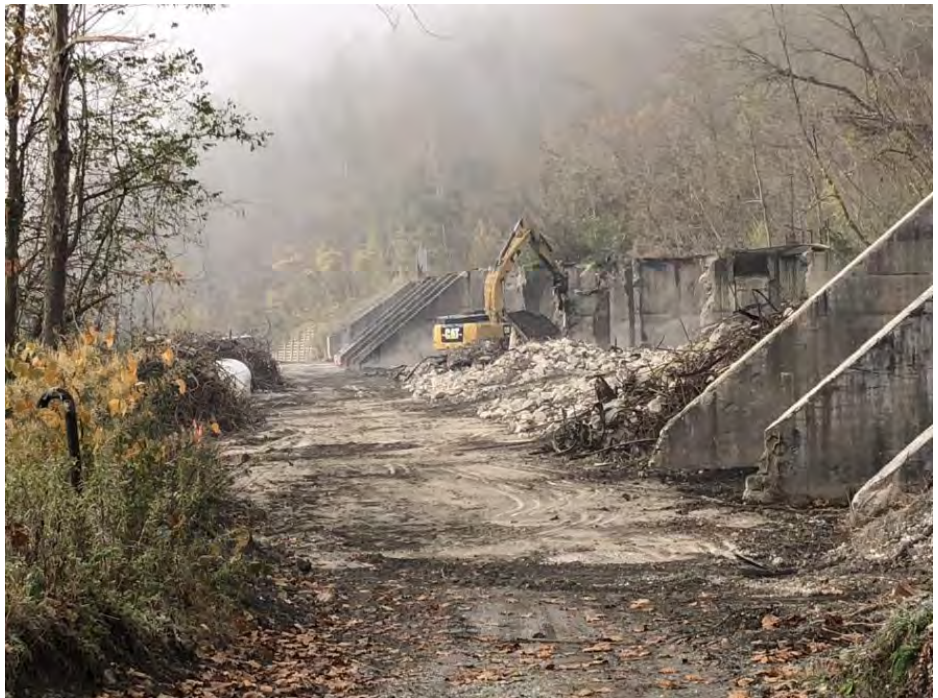
PHOTOGRAPH 26

Excavator with pulverizer attachment demolishing concrete at the north ore bins.

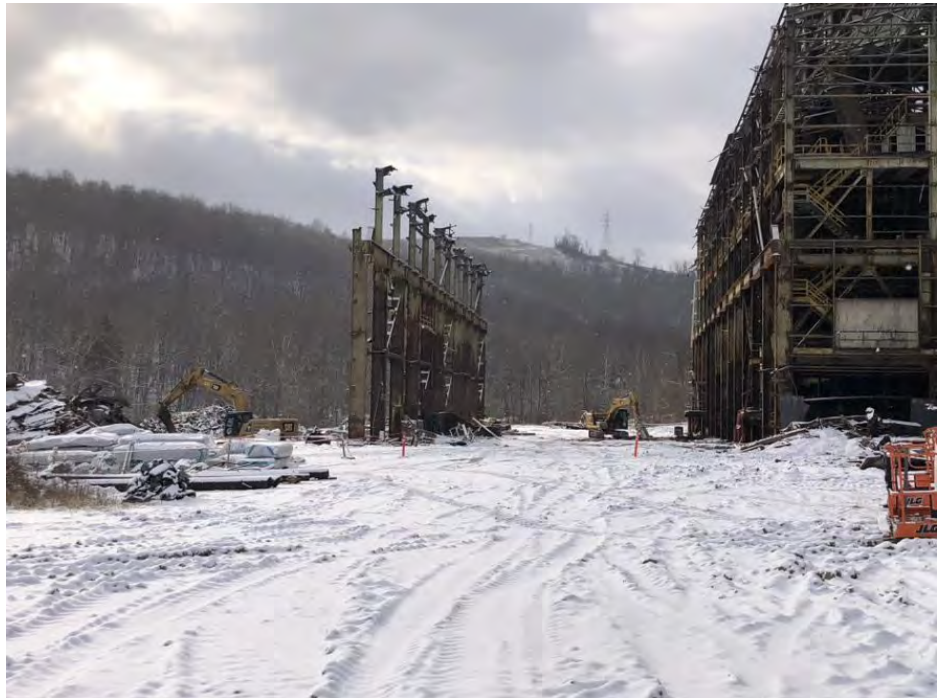
PHOTOGRAPH 27

Demolition of the South Mill Building.

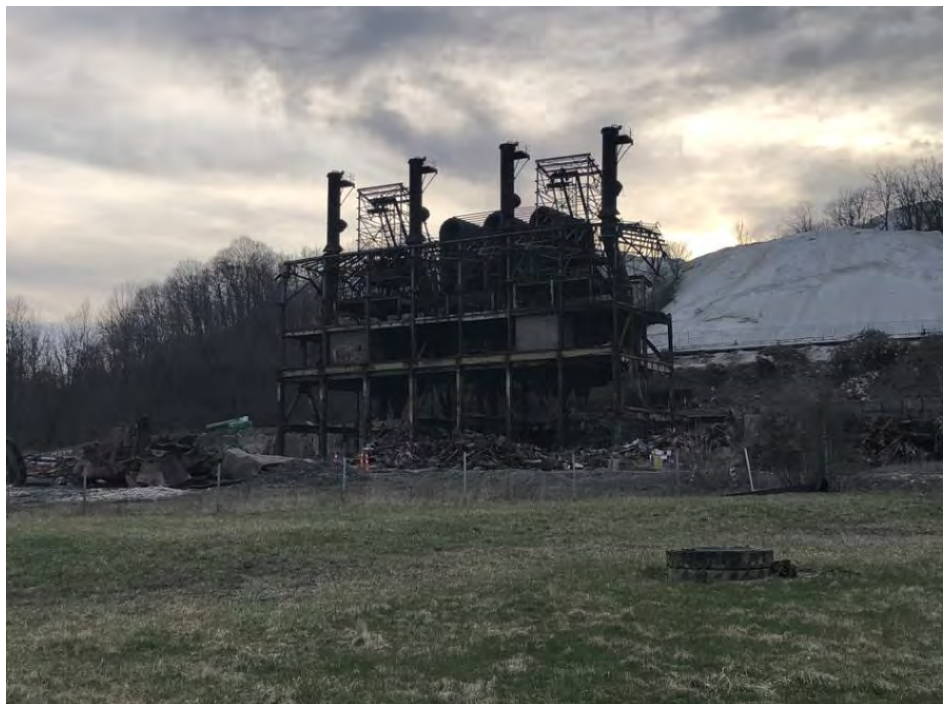
PHOTOGRAPH 28

Remaining South Mill Building structure before felling.

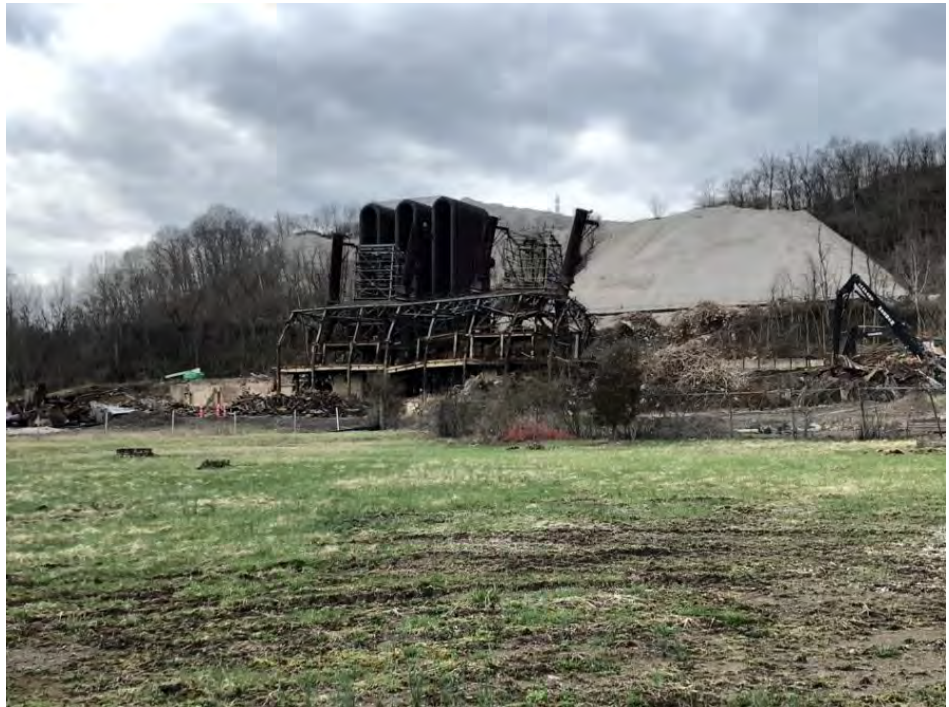
PHOTOGRAPH 29

Remaining South Mill
Building structure after
felling.

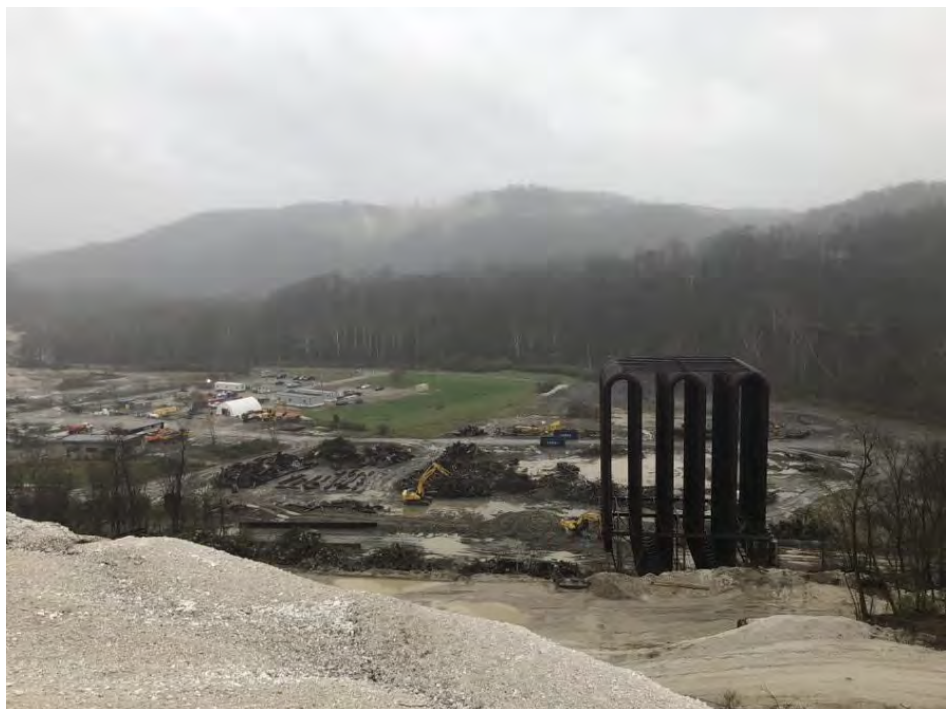
PHOTOGRAPH 30

Footprint of the South Mill
Building after demolition.

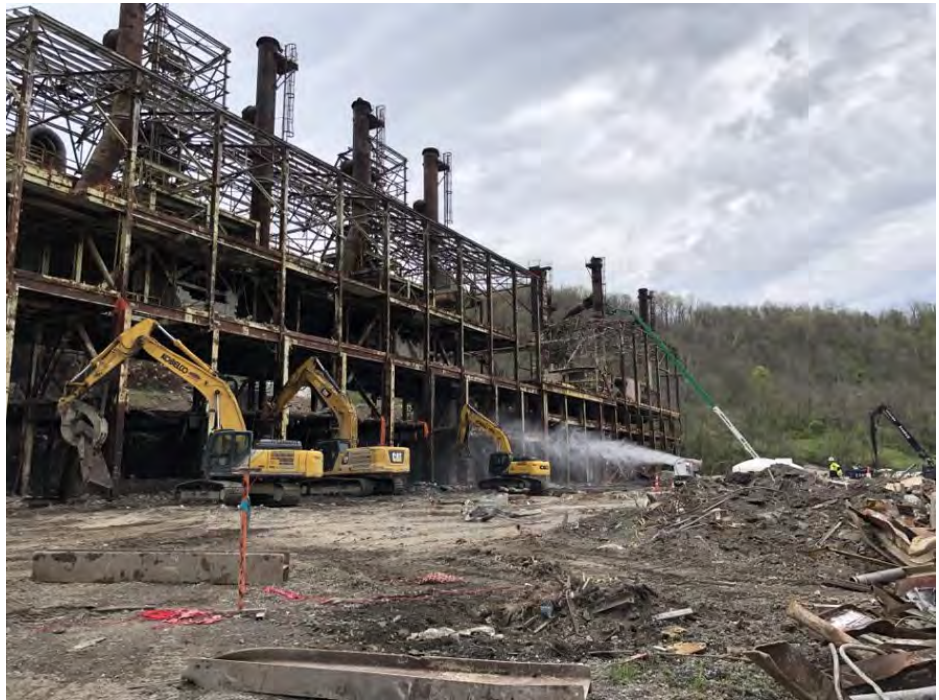
PHOTOGRAPH 31

Demolition at the North Mill Building.

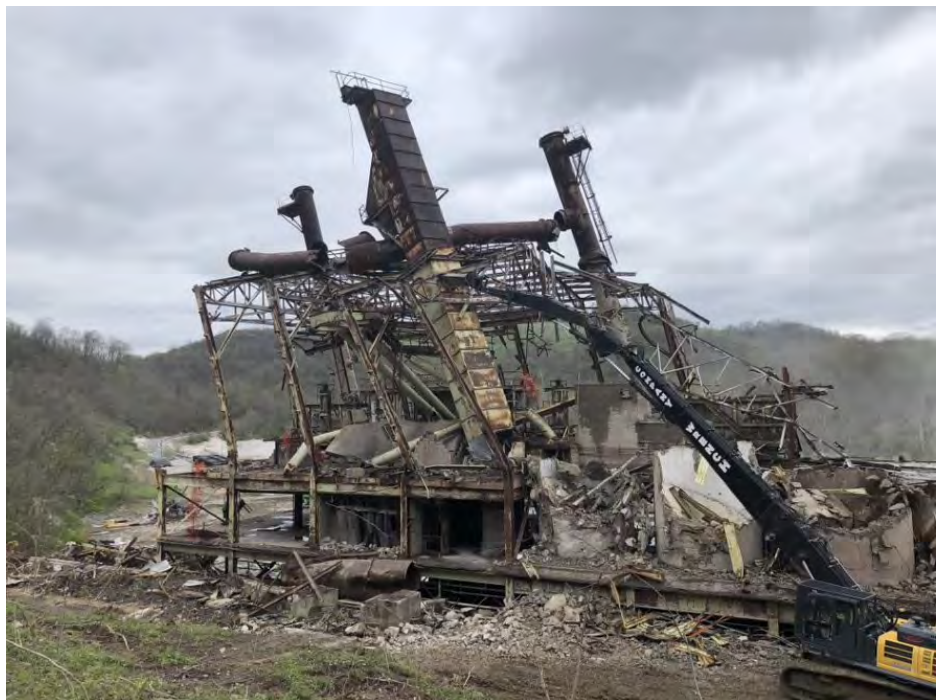
PHOTOGRAPH 32

Demolition of a portion of the North Mill Building with the long-reach excavator.

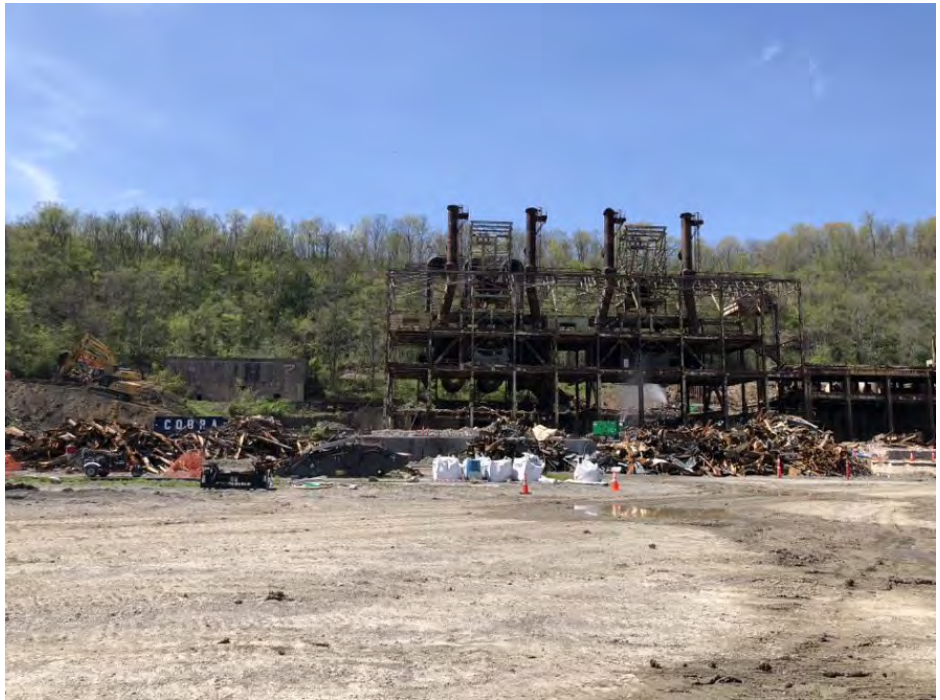
PHOTOGRAPH 33

Remaining North Mill
Building structure before
felling.

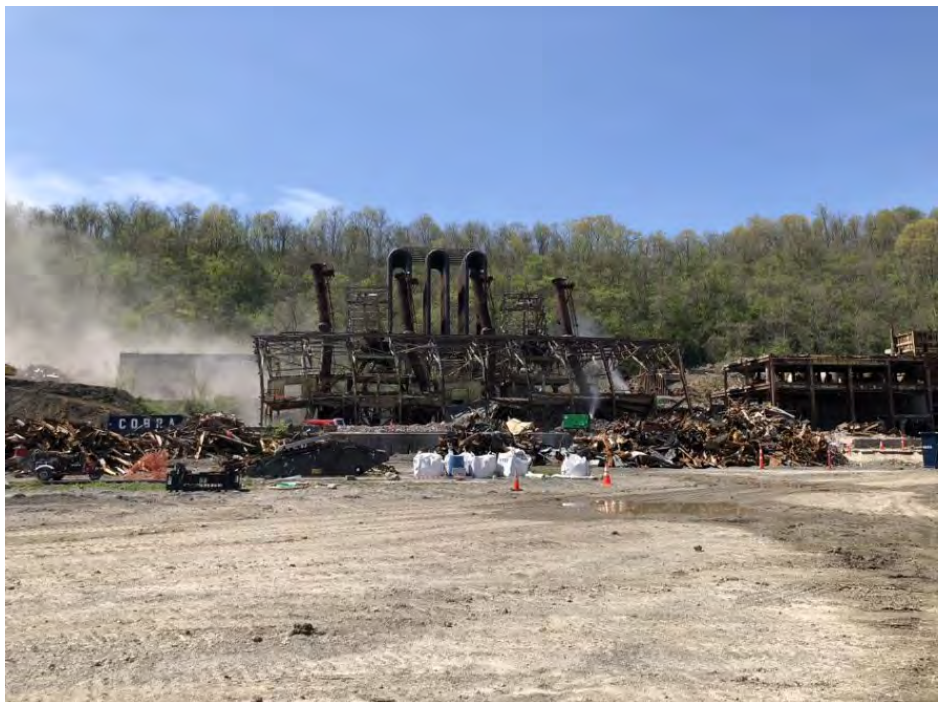
PHOTOGRAPH 34

Remaining North Mill
Building structure after
felling.

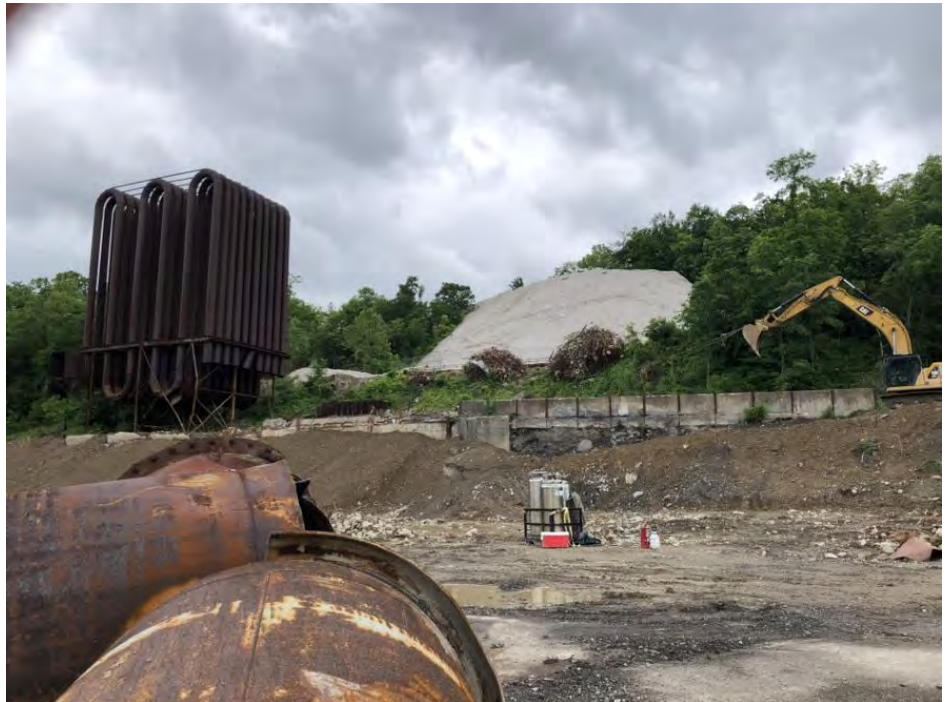
PHOTOGRAPH 35

South off-gas pipes before felling.

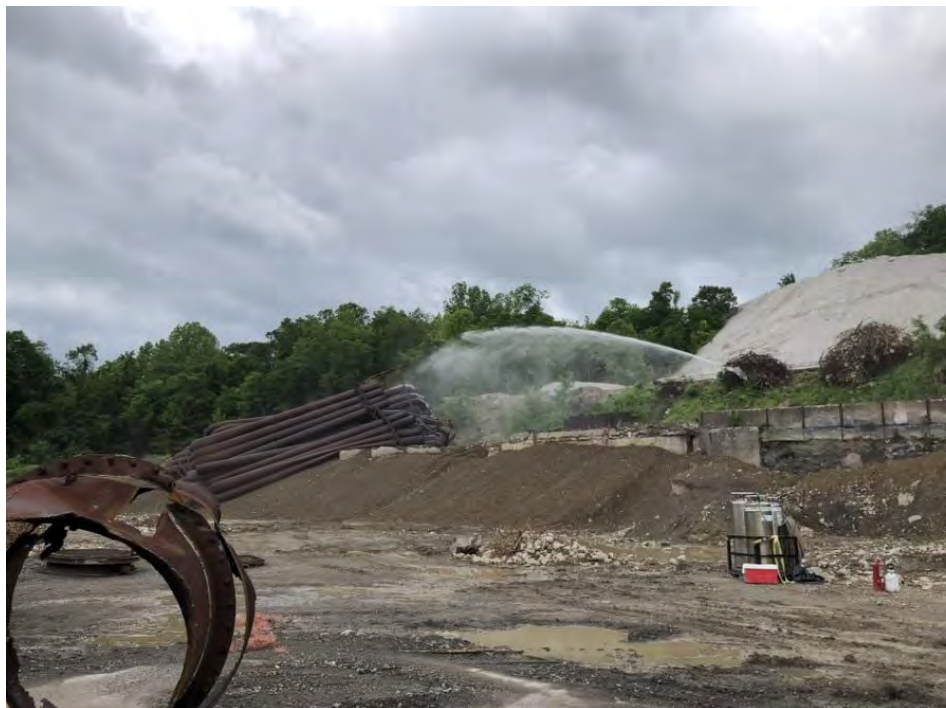
PHOTOGRAPH 36

South off-gas pipes after felling.
