Stage 2 Interim Action Report for the Former Satralloy Site (Jefferson County, Ohio)

Cyprus Amax Minerals Company

WSP USA Inc.

October 2023

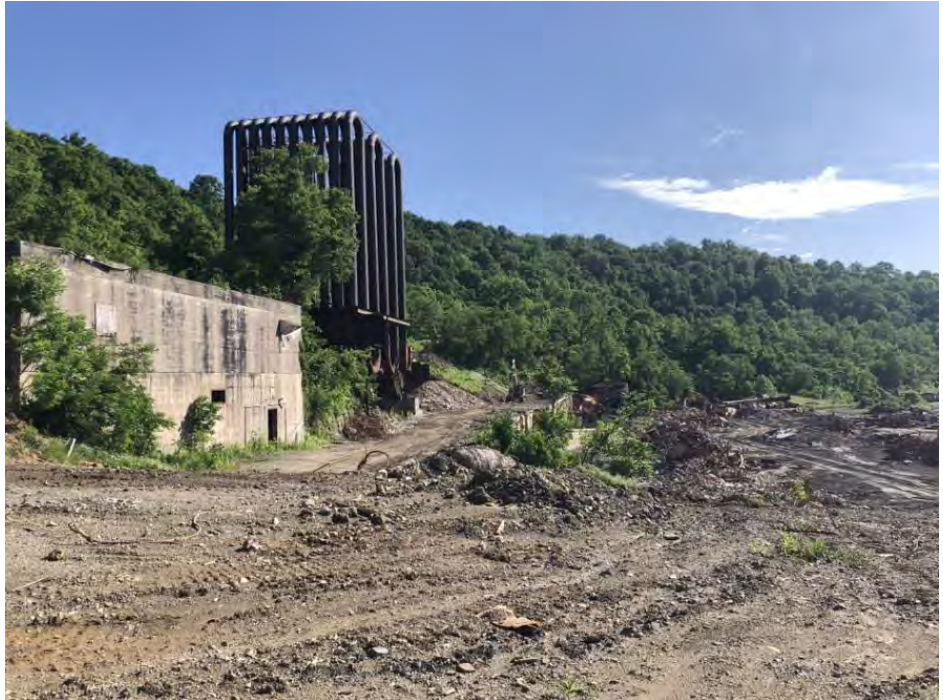
PHOTOGRAPH 37

North off-gas pipes before felling.

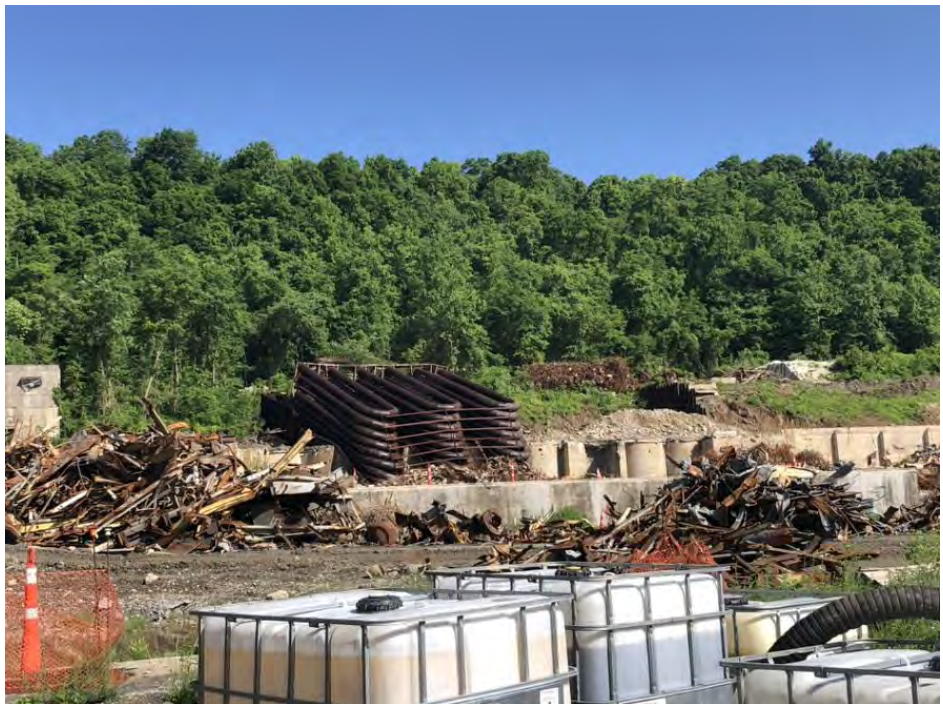
PHOTOGRAPH 38

North off-gas pipes after felling.

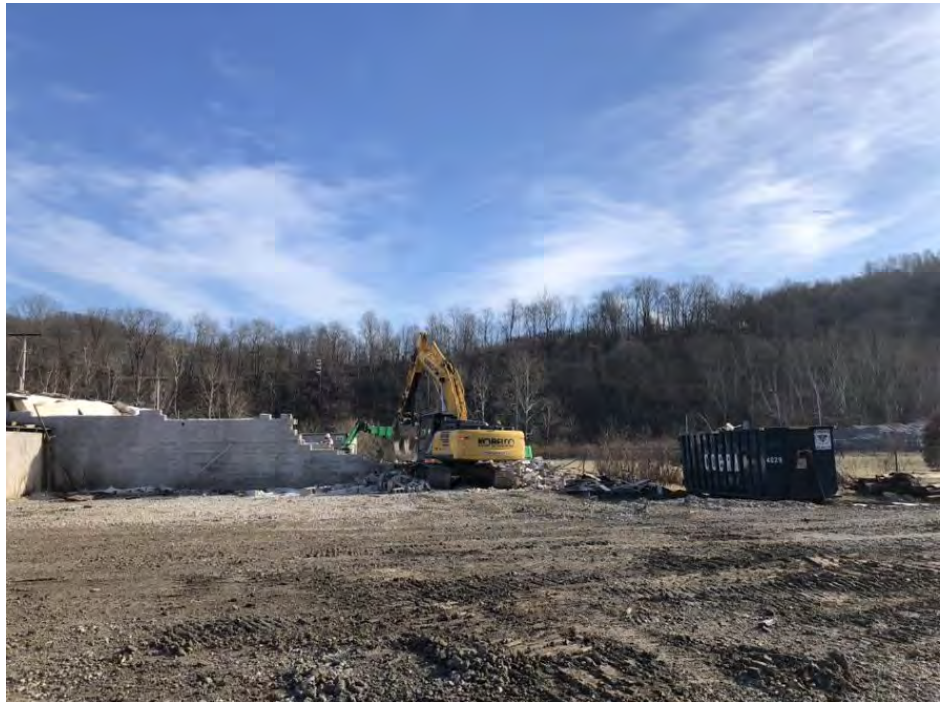
PHOTOGRAPH 39

Demolition of the
administration building.

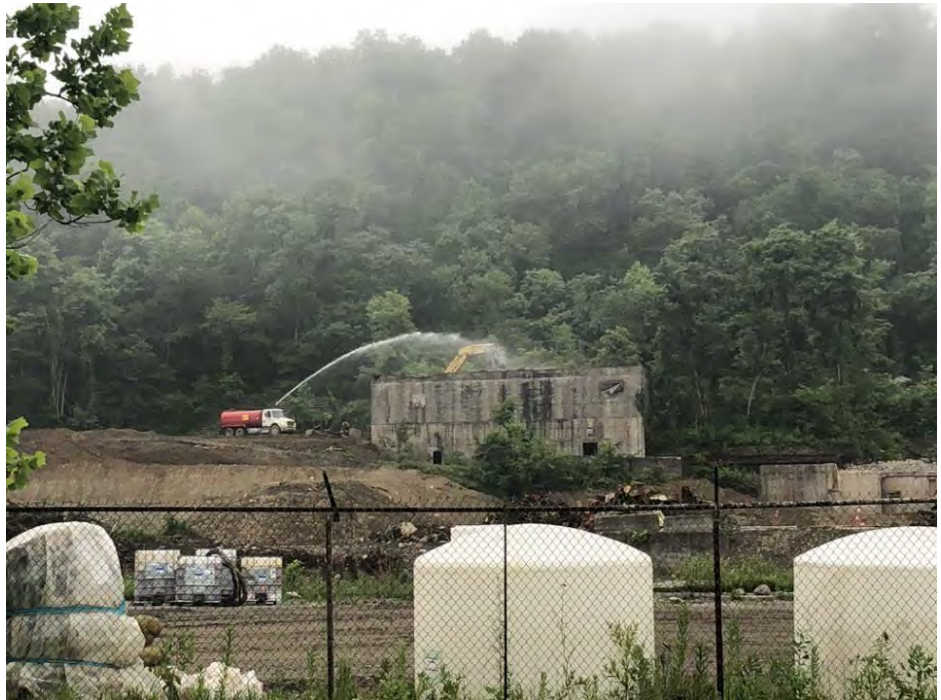
PHOTOGRAPH 41

Demolition of the electrical building.

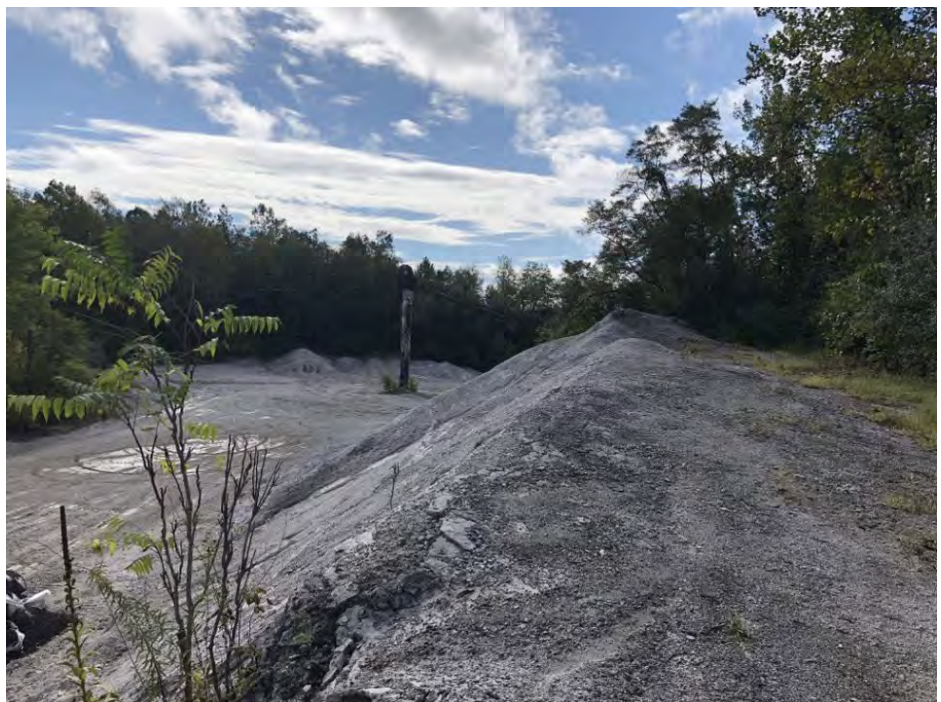
PHOTOGRAPH 42

Slurry tower before demolition.

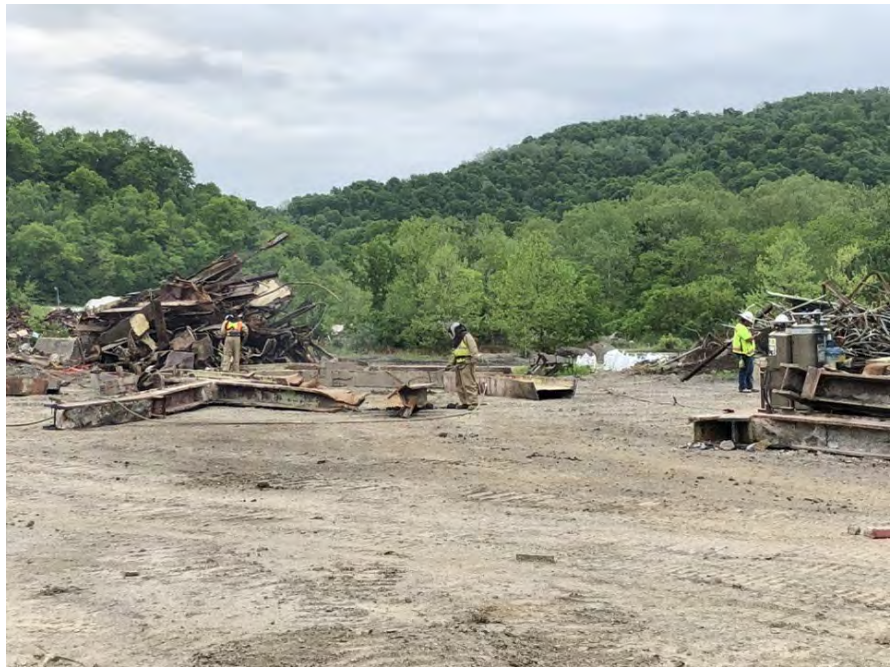
PHOTOGRAPH 45

Using torches to cut scrap metal.

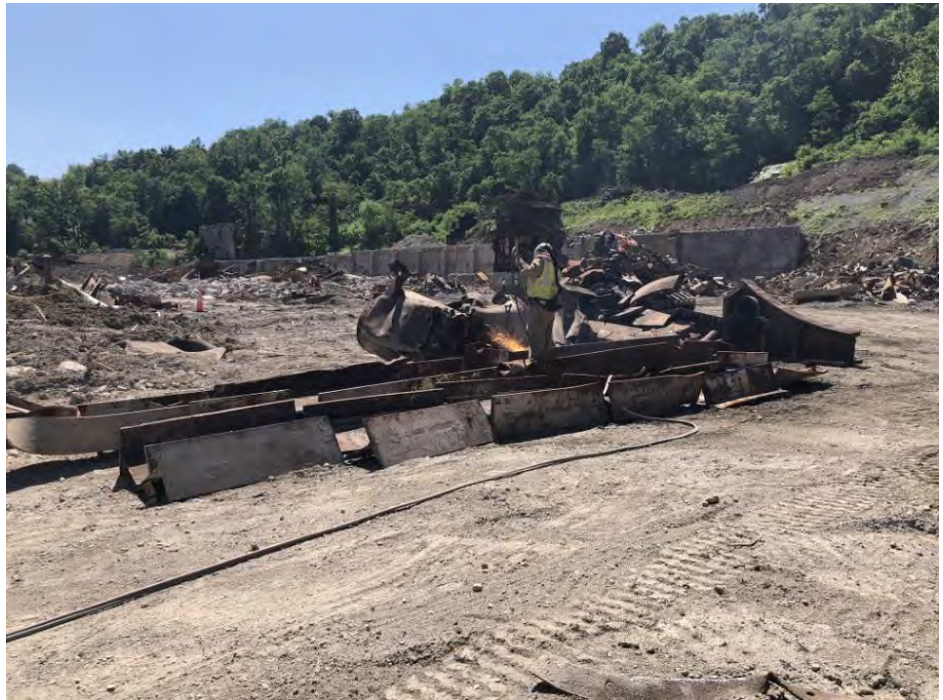
PHOTOGRAPH 46

Using torches to cut scrap metal.

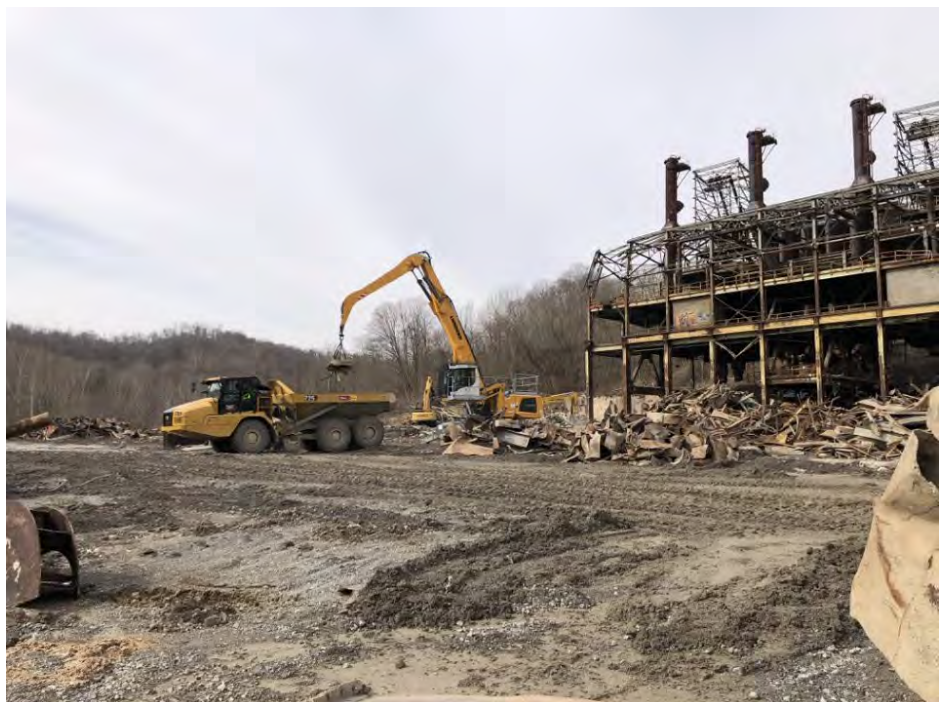
PHOTOGRAPH 47

Loading pieces of scrap metal into haul truck.

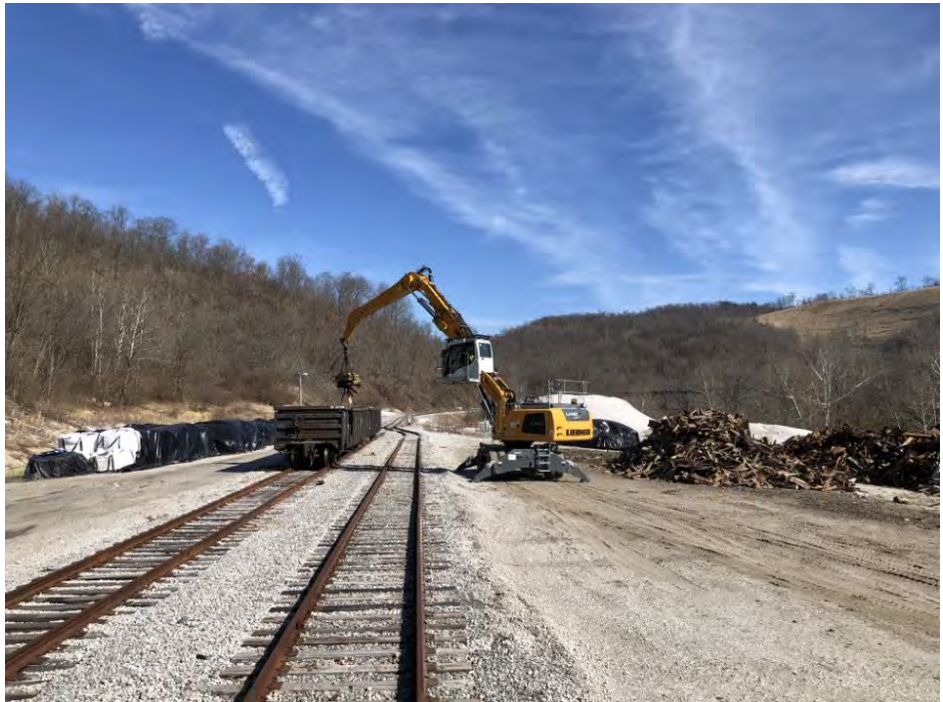
PHOTOGRAPH 48

Loading pieces of scrap metal into rail gondola.

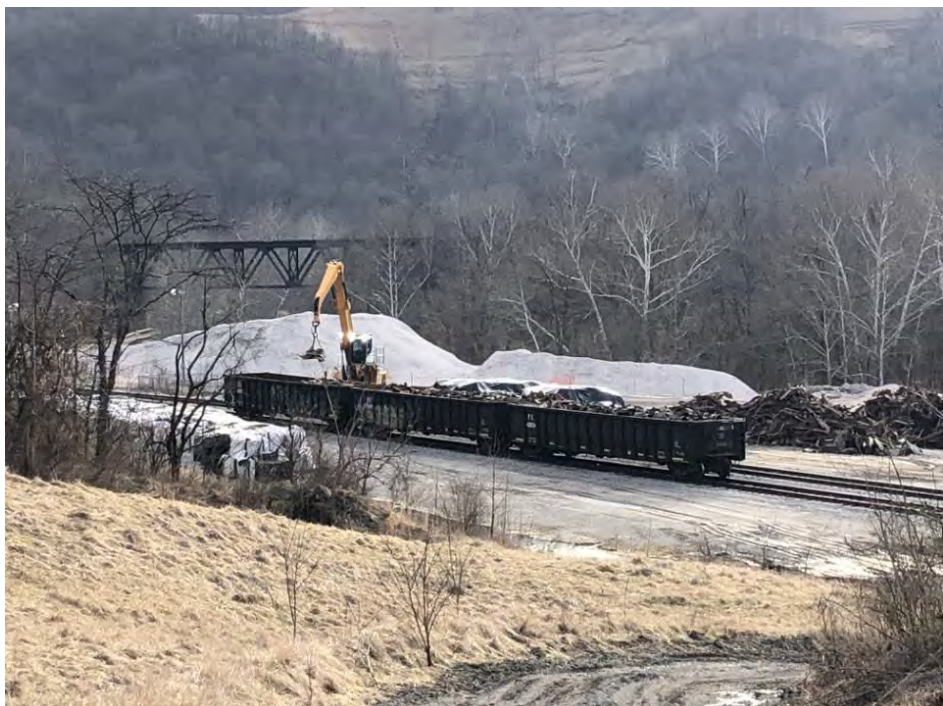
PHOTOGRAPH 49

Loading pieces of scrap metal into rail gondola.

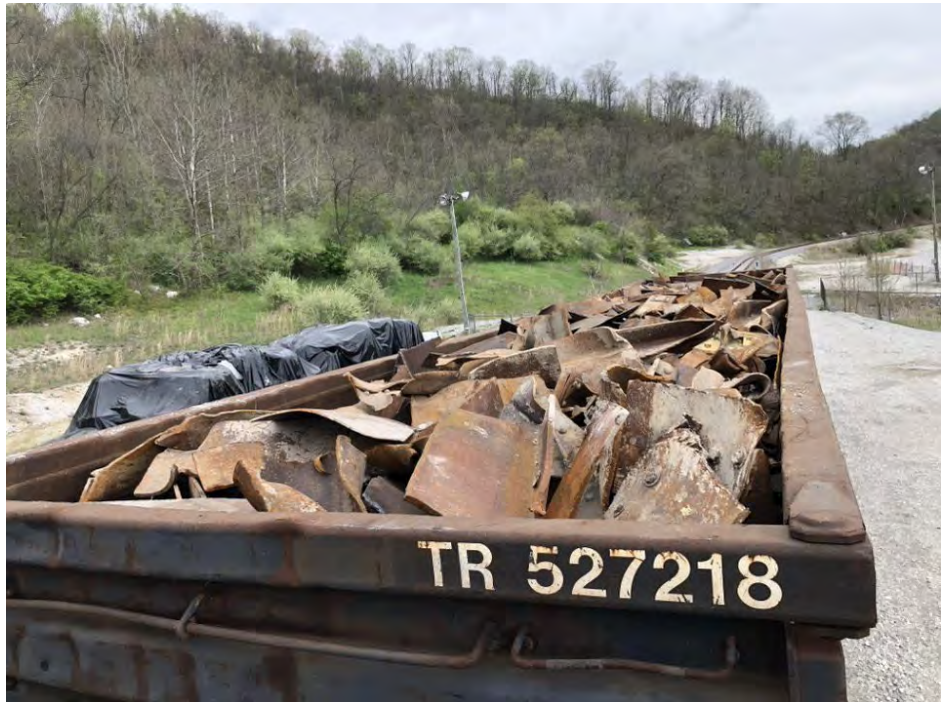
PHOTOGRAPH 50

Loaded rail gondola with
scrap metal.

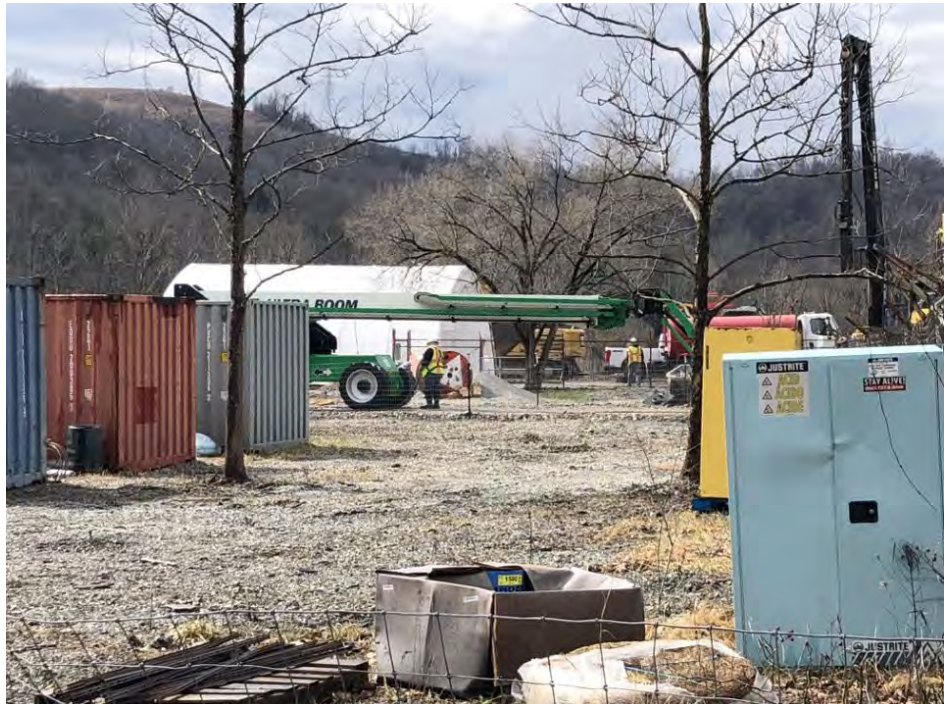
PHOTOGRAPH 54

Decontamination of equipment exiting the exclusion zone.

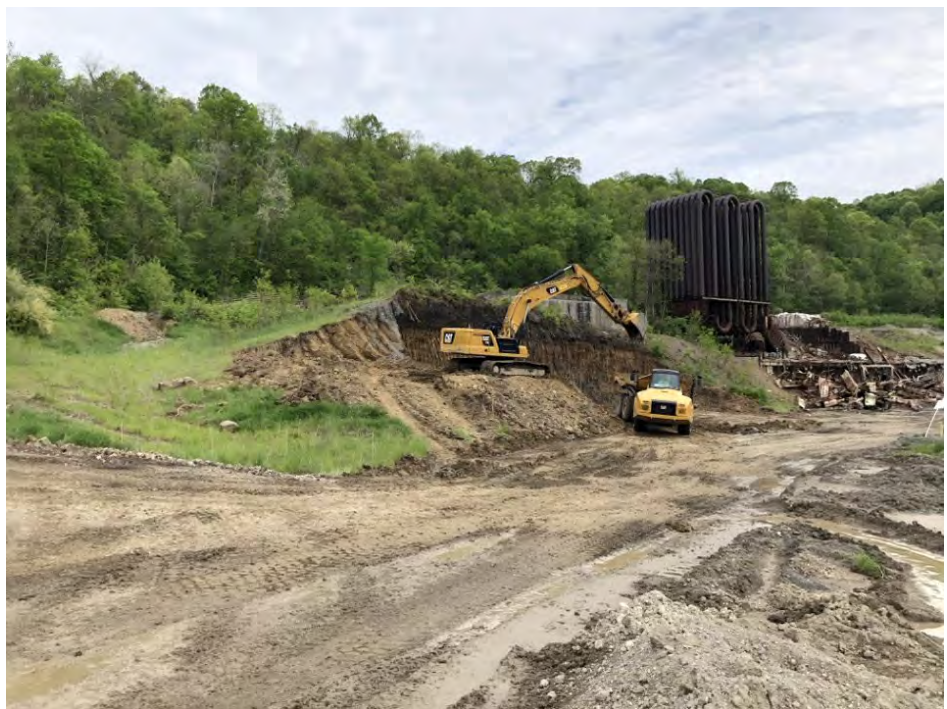
PHOTOGRAPH 55

Excavation of soil for backfill at Borrow Area 1G.

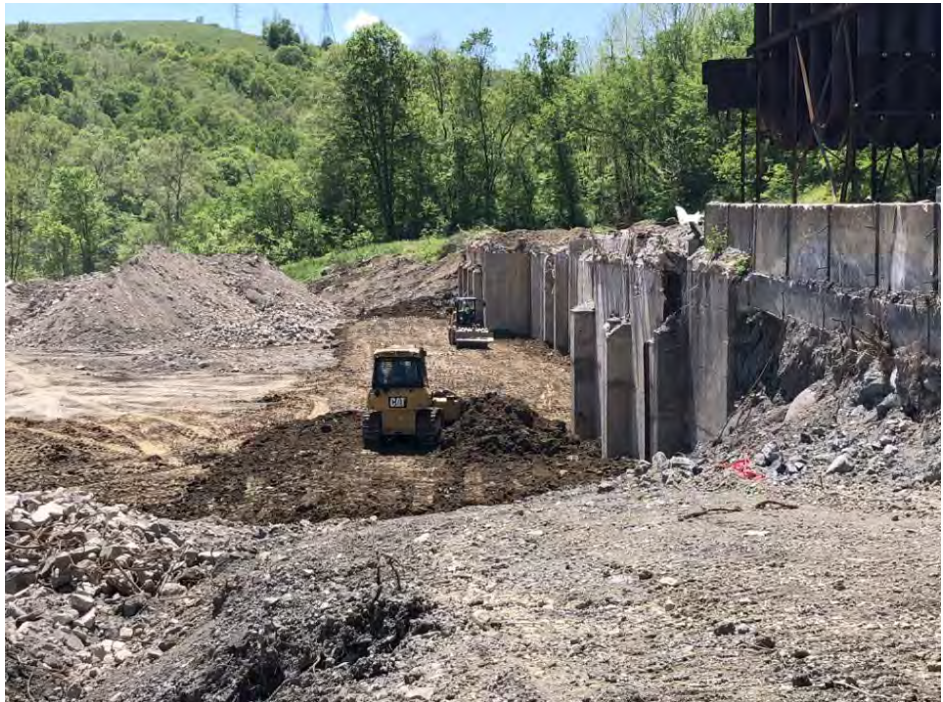
PHOTOGRAPH 56

Backfill and compaction of safety slope against the foundation wall of the South Mill Building.

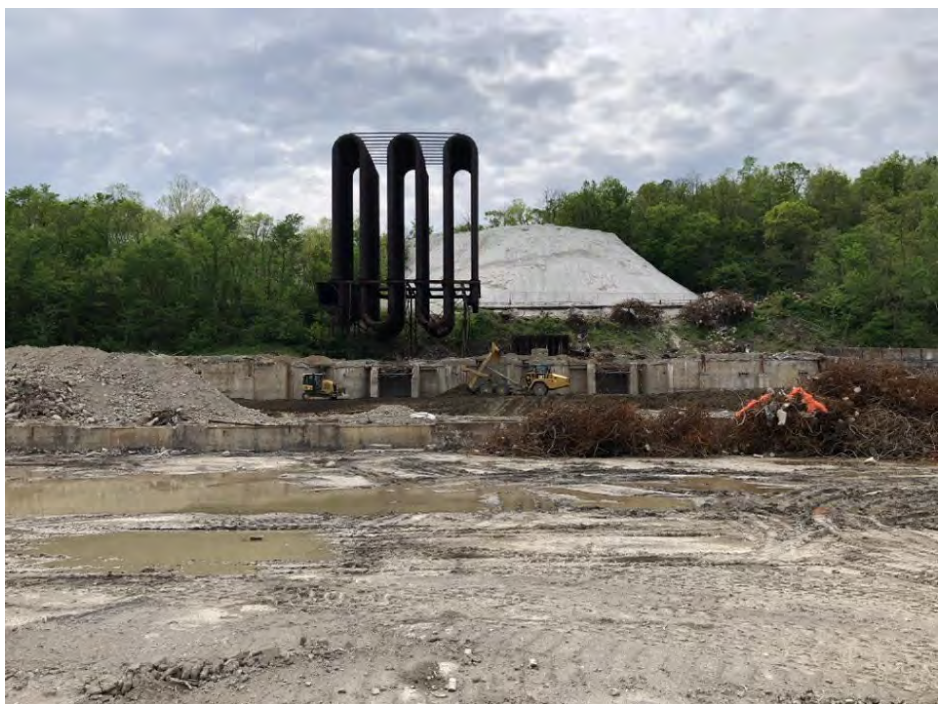
PHOTOGRAPH 57

Backfill of safety slope against the foundation wall of the South Mill Building.

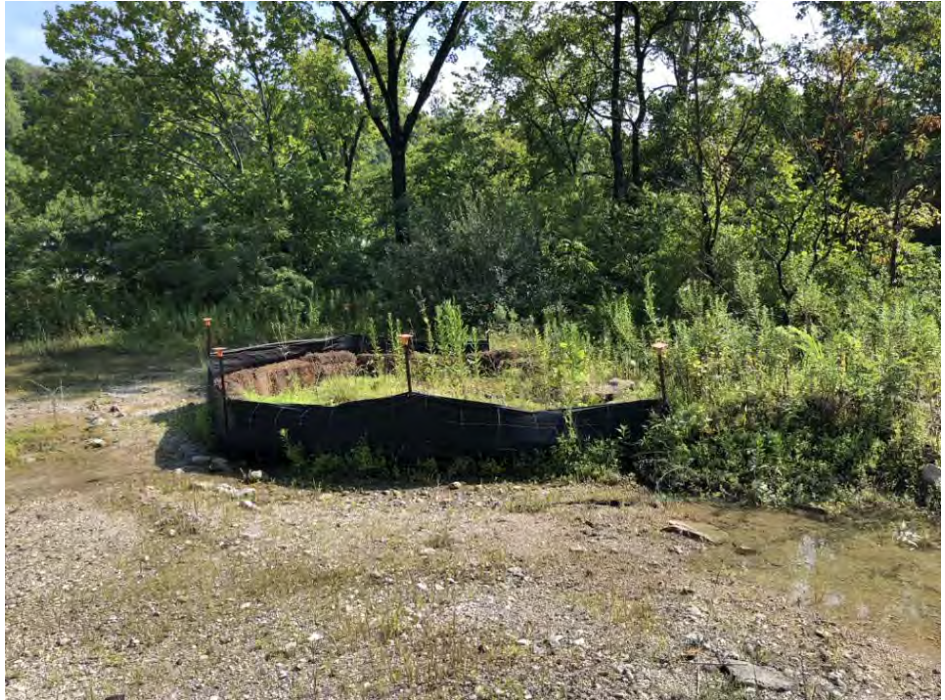
PHOTOGRAPH 58

Silt fence and straw bales around a drainage feature for stormwater control.

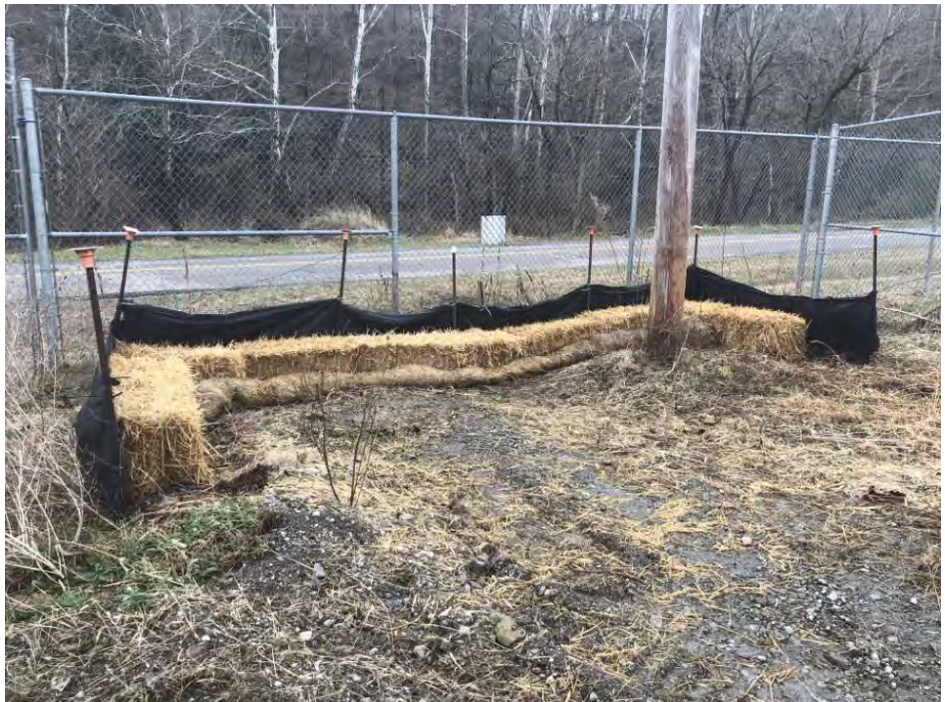
PHOTOGRAPH 59

Silt fence and straw bales around a drainage feature for stormwater control.

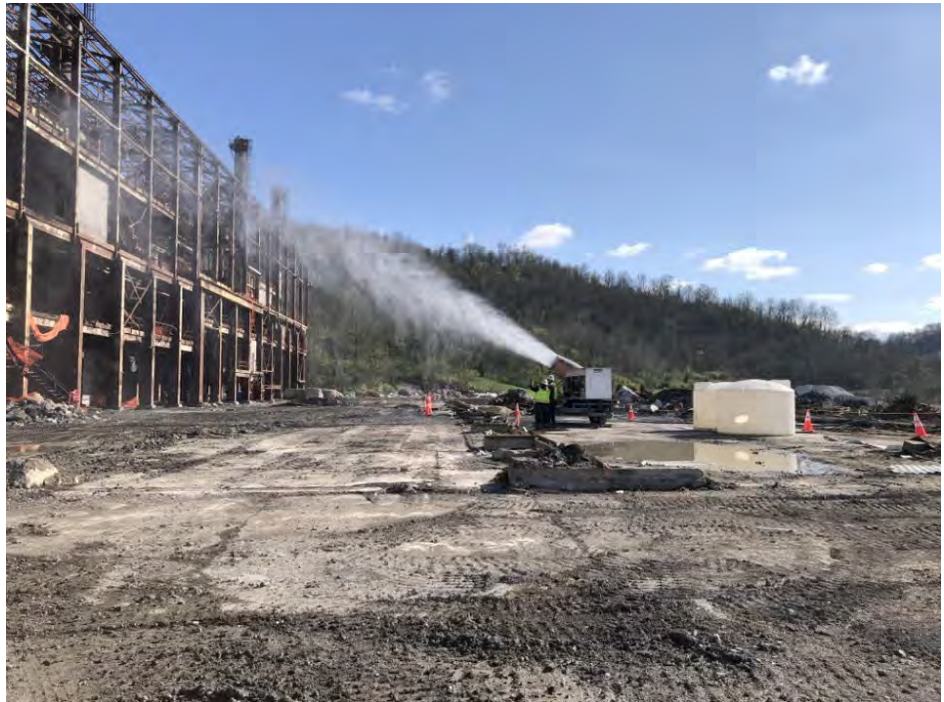
PHOTOGRAPH 60

Water spray for dust control during demolition at the North Mill Building.

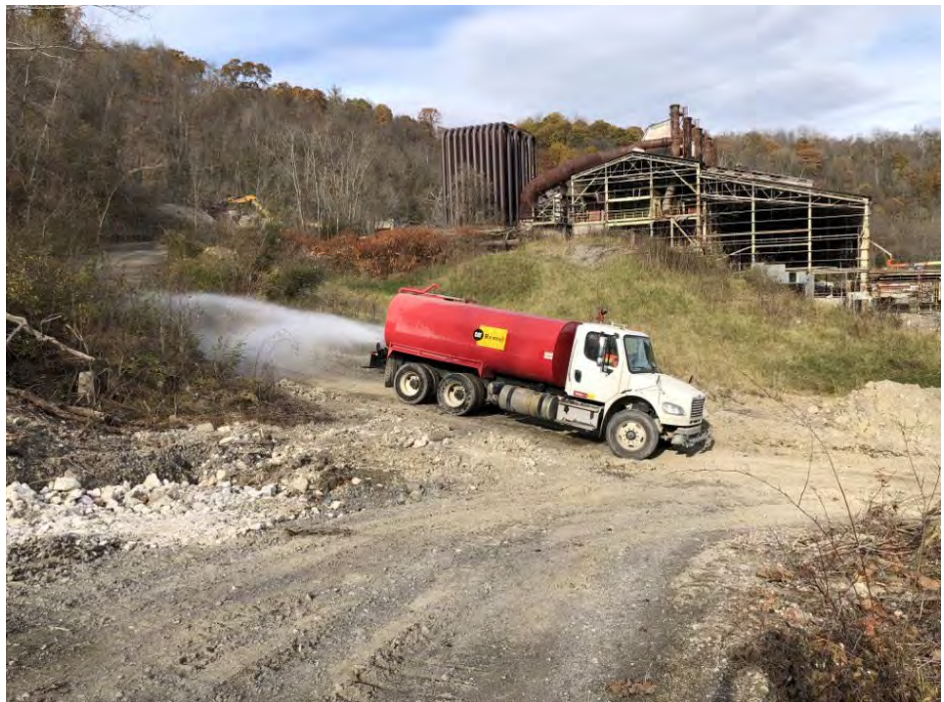
PHOTOGRAPH 61

Watering a site road for dust control.

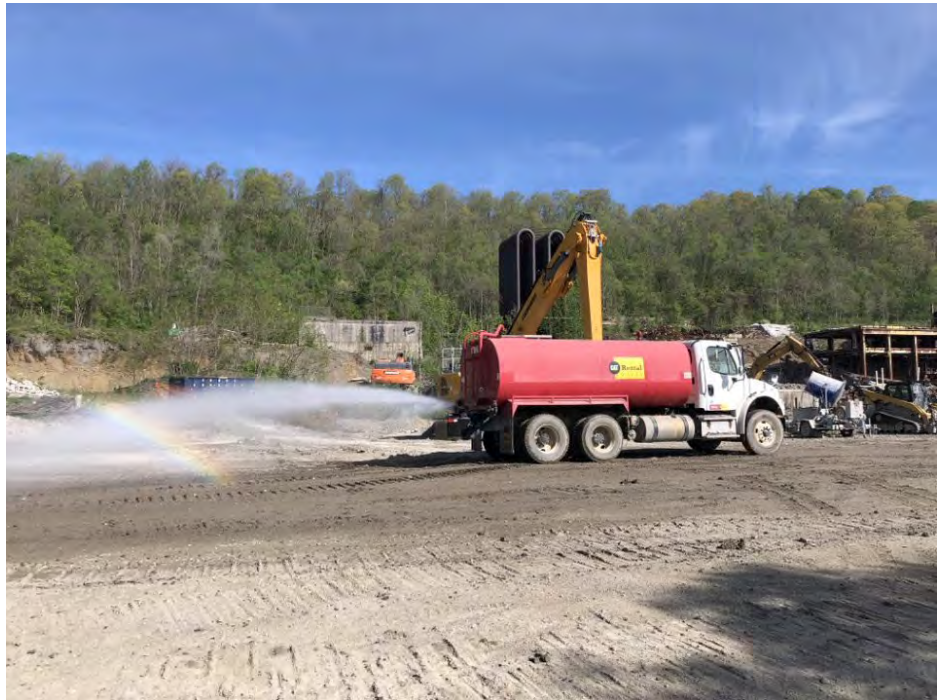
PHOTOGRAPH 62

Watering a site road for dust control.

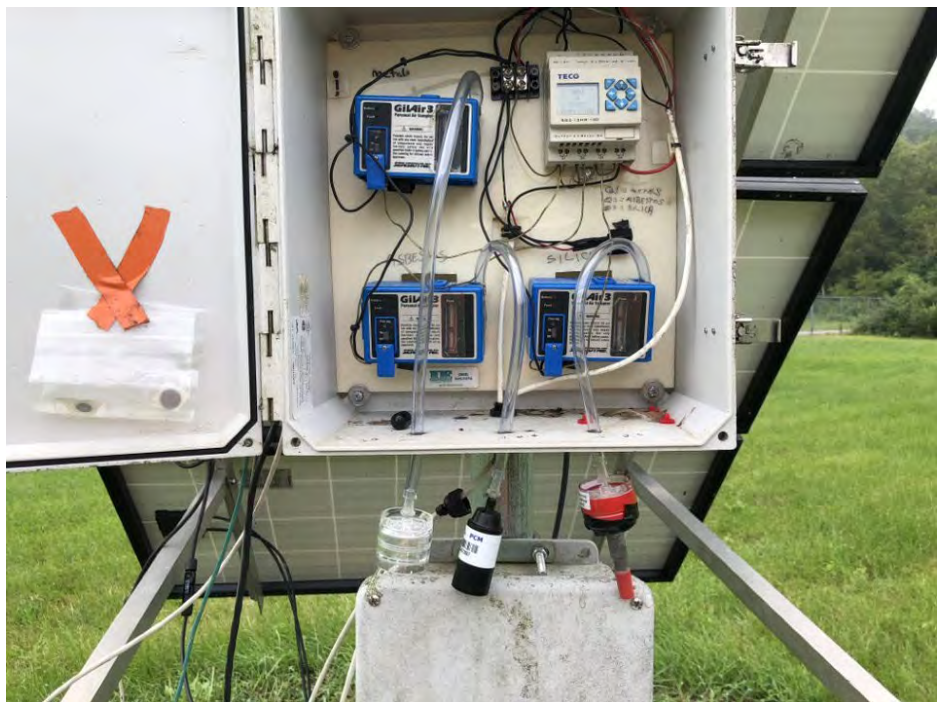
PHOTOGRAPH 63

Perimeter air sampling equipment.

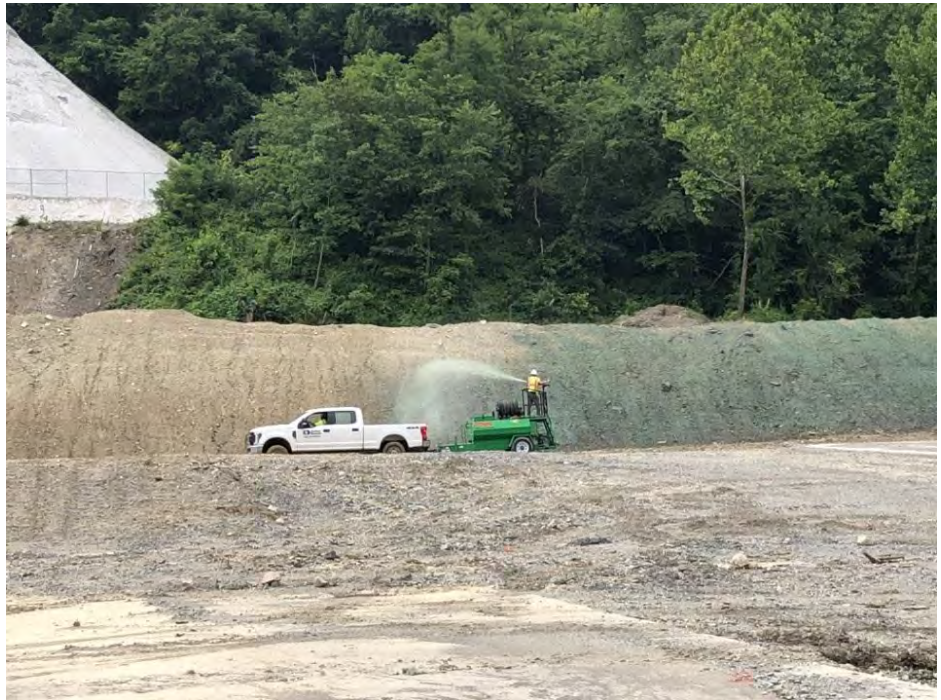
PHOTOGRAPH 64

Spraying hydroseed to the backfilled safety slope at the former South Mill Building.

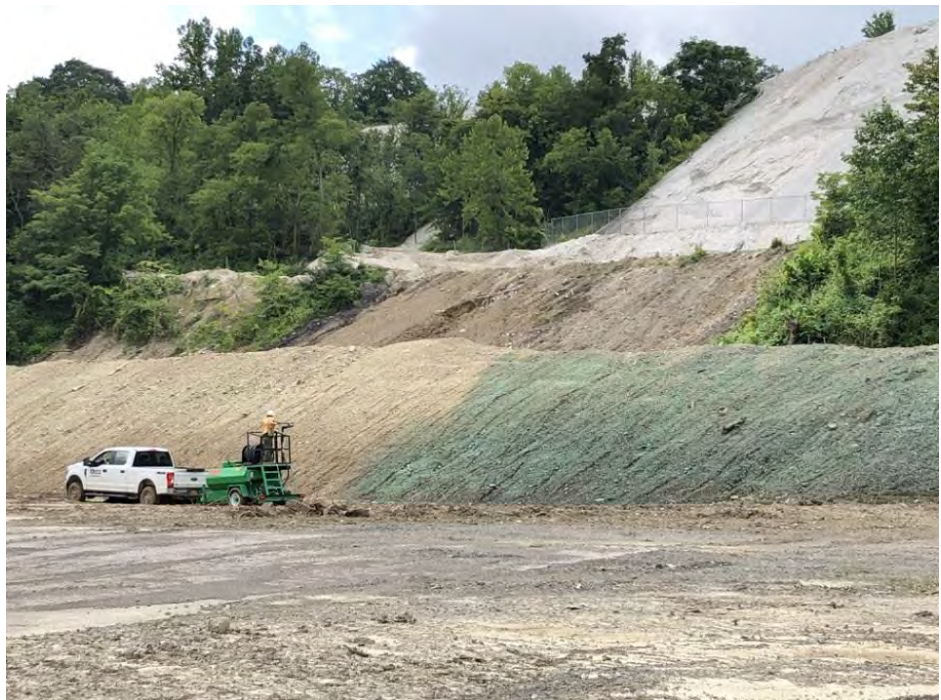
PHOTOGRAPH 65

Spraying hydroseed to the backfilled safety slope at the former South Mill Building.

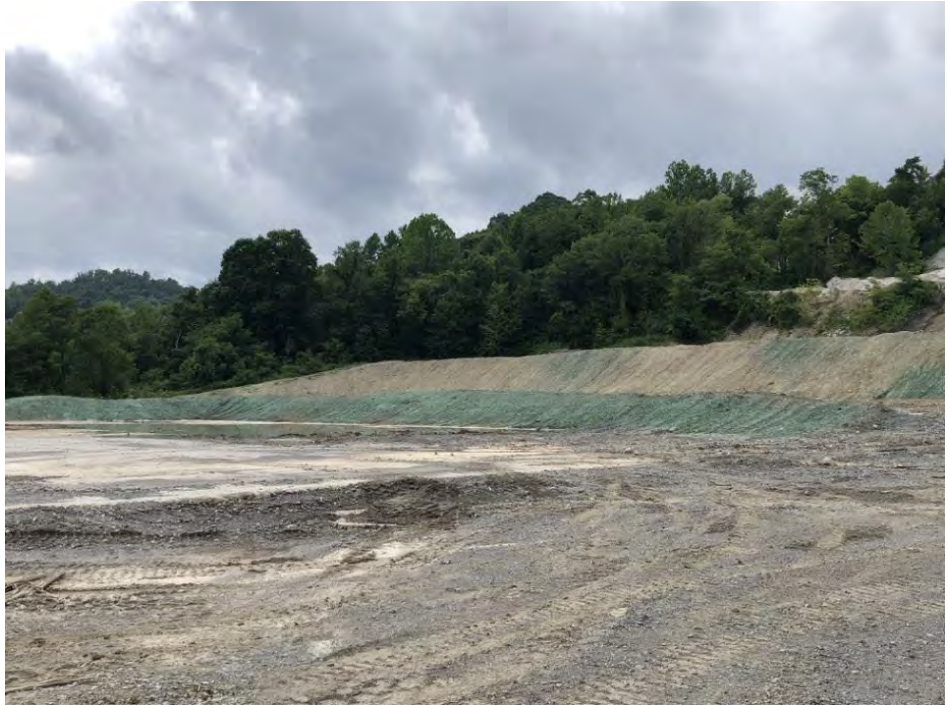
PHOTOGRAPH 66

Former South Mill Building area right after hydroseed application.

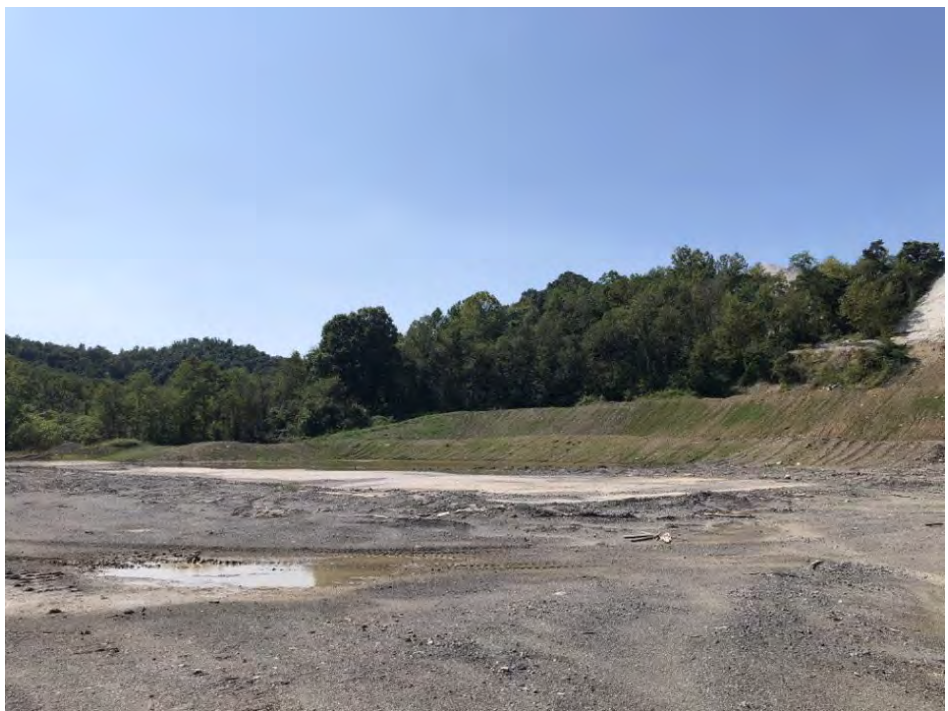
Former South Mill Building area, several weeks after hydroseed application.
